City of Iqaluit

Preliminary Design Report

Creekside Village Watermain Replacement

OTT-00225312-A0

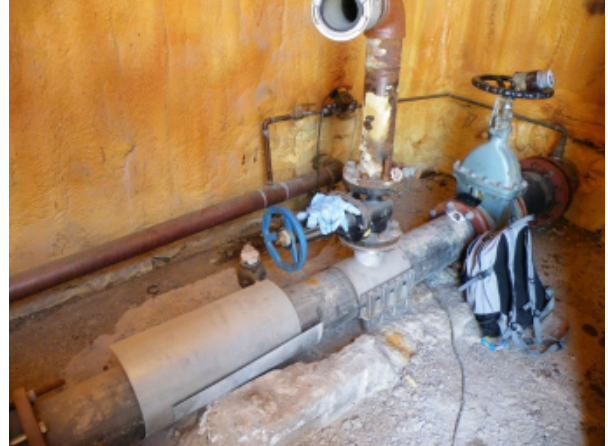
The Creekside Village watermain initiates in a small metal building adjacent to the Astro Hill Complex. The piping enters the building as 250 mm diameter HDPE and immediately reduces to 200 mm. A relatively recently installed valve is situated on the 200 mm HDPE piping. City staff reports that this valve is functional. This metal building also contains the service connection to a portion of the Astro Hill Complex. It was noted that the service connection is not equipped with an isolation valve. The internal arrangement at this building is depicted in the adjacent photograph.

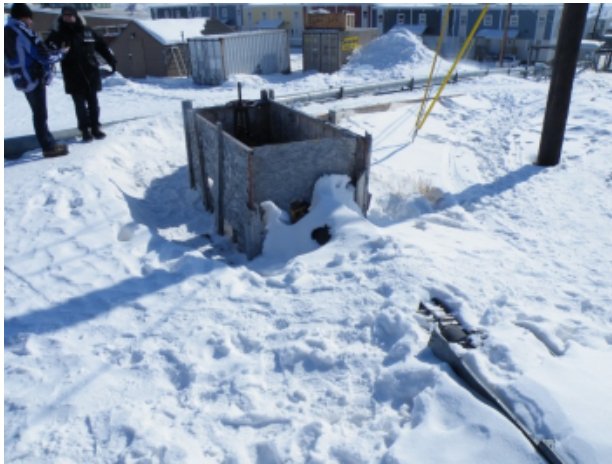
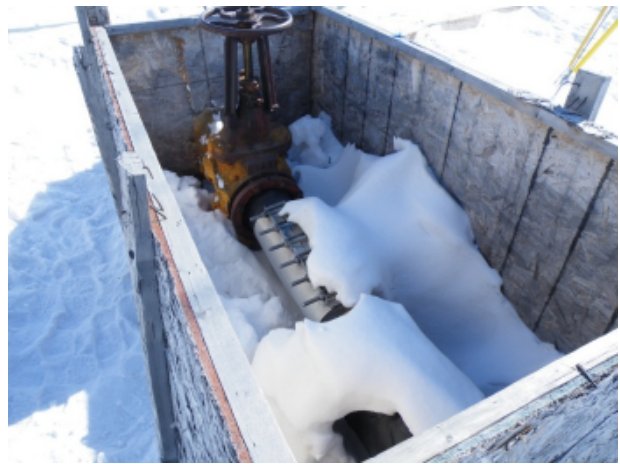
The 200 mm HDPE watermain extends approximately 40 metres from the metal building to a valve and concrete thrust block. A 45° bend is situated within the thrust block. A pair of repair clamps has been installed on the HDPE piping within 4 metres of the thrust block. The plywood enclosure surrounding the valve is in an advanced state of deterioration leaving the valve poorly enclosed and at risk of freeze and vandalism. This valve is currently not essential for operational reasons, as this function can be provided by the valve situated upstream in the metal building. Photographs below depict the arrangement in the vicinity of the thrust block.

Based upon the above it is concluded that replacement of the piping between the repair clamp 4 metres uphill from the thrust block and existing transition to HDPE piping at the southernmost pair of row housing units is prudent.

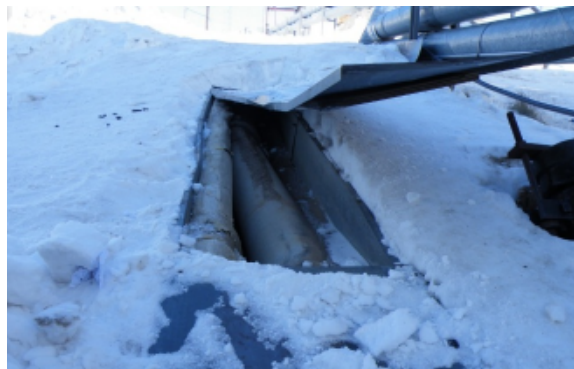
Near the northern most row housing unit there was an opportunity to for City staff to open the metal enclosure. The presence of AC piping was confirmed at this location. A sample of the insulation was taken at this location. It was noted that the much of the pipe diameter was not protected by insulation at this location. It was also noted that the AC piping no longer aligned with the centreline of the enclosure. The adjacent photograph 4 depicts conditions at this location. A sample of the insulation was captured at this location, and an analysis of this insulation is currently being conducted.

A sample of the insulation within the metal enclosures was obtained during the site visit. This sample has been sent for analysis. The findings of this analysis must be incorporated into the construction documents.

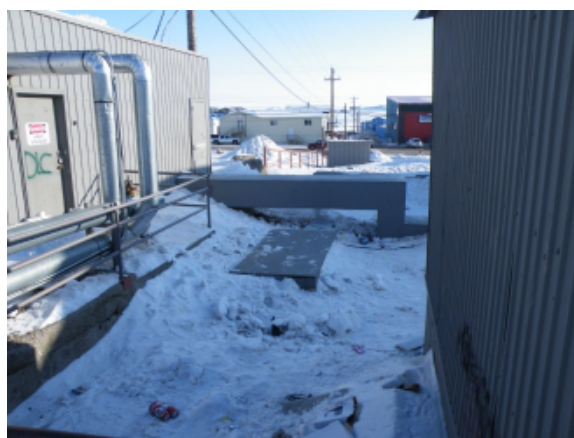
A wooden box has been constructed at a location between the pair of row housing units in closest proximity to Queen Elizabeth Way. It was reported by City staff, that this box was installed to protect a transition from AC to HDPE piping. It was further reported that the piping between this point and the metal shelter adjacent to Queen Elizabeth Way had been replaced with HDPE piping due to damage by construction equipment. This recent replacement is approximately 38 metres in length. Specific details regarding the method of connection between the AC and HDPE piping were not examined during the site visit as extensive investigations into the wooden box were not felt to be prudent at the time of the visit due to ongoing cold weather conditions. The location of the wooden enclosure is depicted the adjacent photograph.

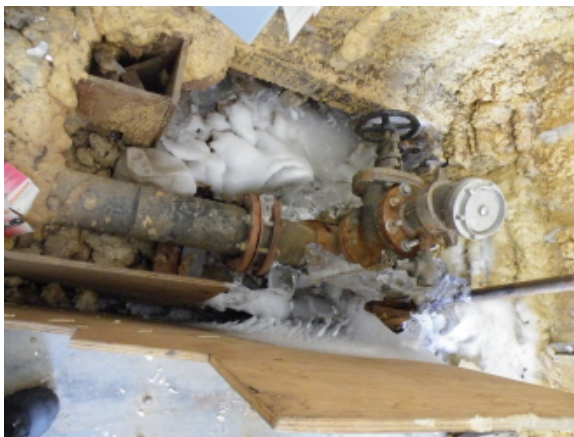
During the site visit it was confirmed that the piping within the metal shelter at Queen Elizabeth Way is 150 mm diameter HDPE, and that there is a valve within the shelter. The conditions with this metal shelter are depicted in the adjacent photograph.
