City of Iqaluit
Master Drainage Plan

Workshop #1

Workshop #2

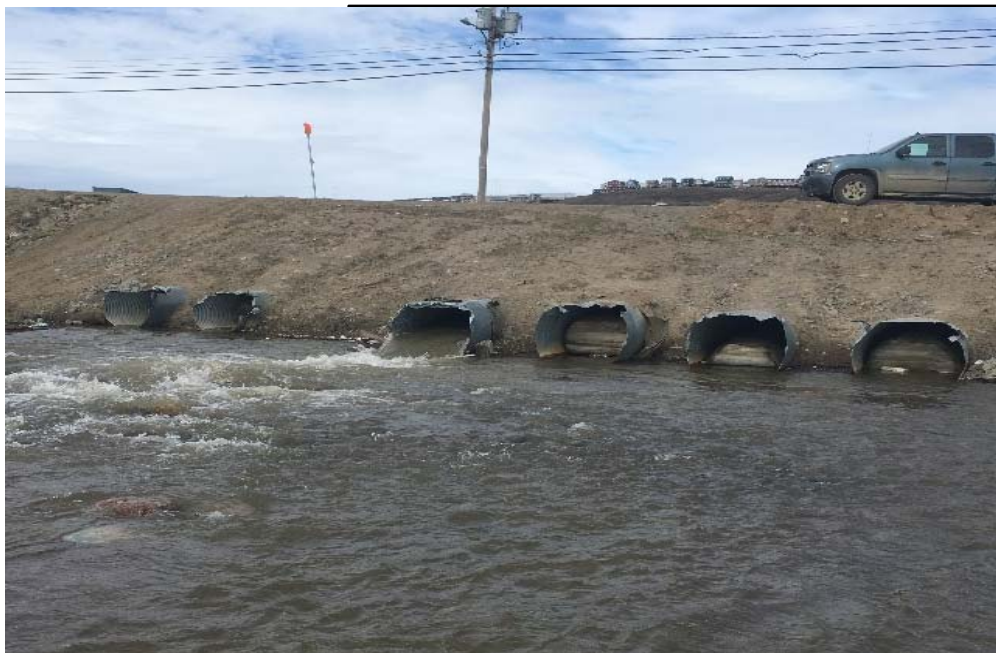
South of Crossing 3 (4 x 1200 mm dia. and 2 x 1000 mm dia.) - Damaged Ends

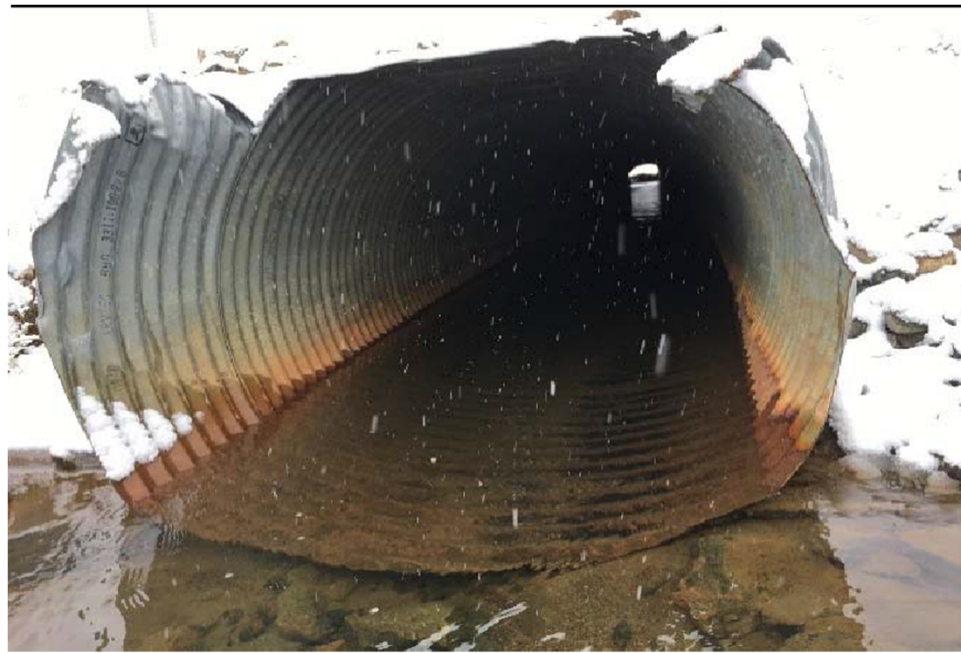
North of Crossing 3 - damaged ends

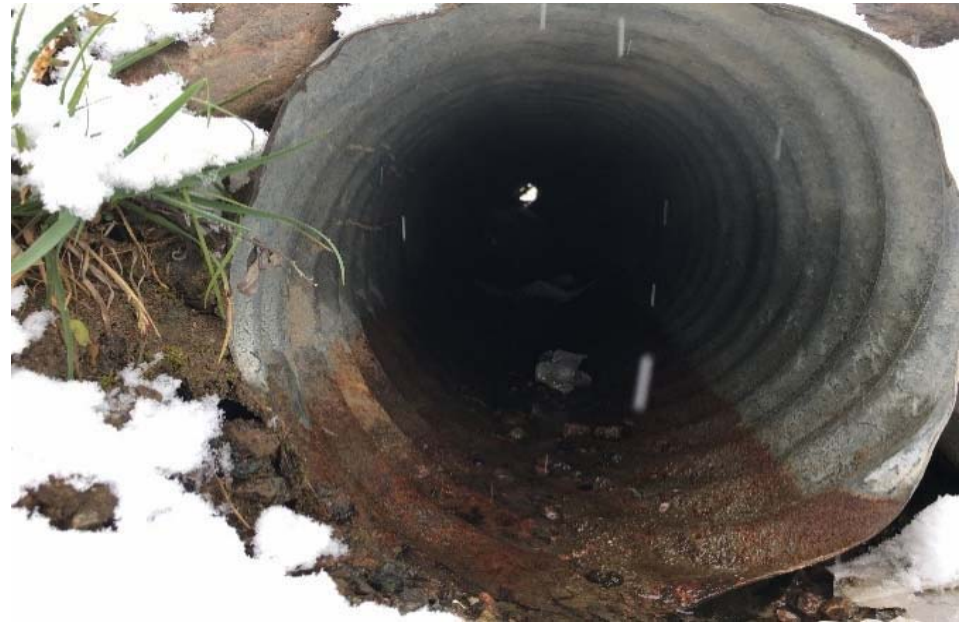
North of Crossing 5 (300 mm dia.) looking Upstream -Corroded
pipe exposed after the removal of garbage

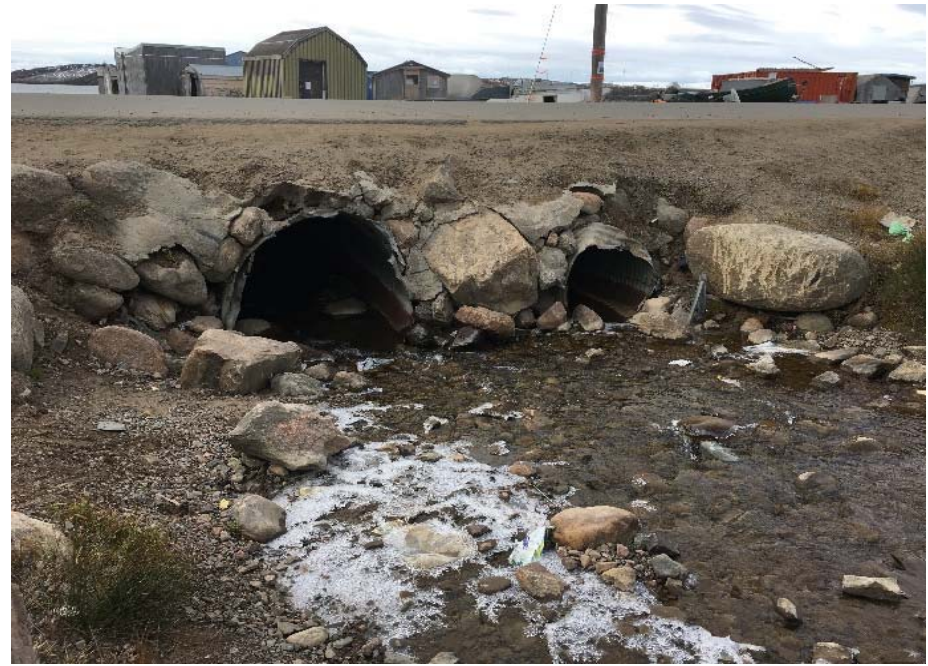
Upstream of Crossing 1 (2 x 700 mm dia.) -
Damaged Ends

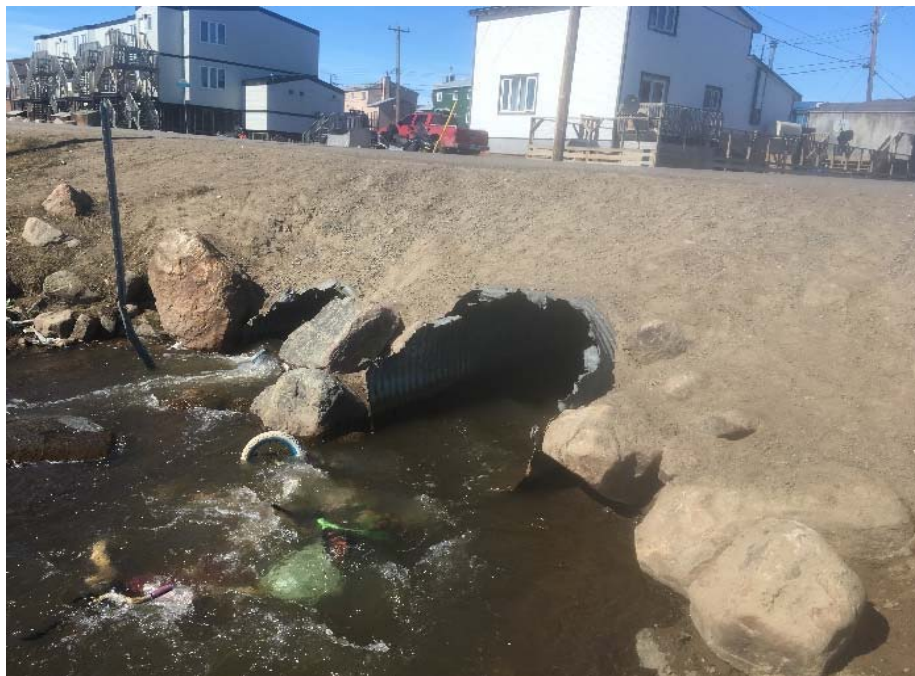
South of Crossing 1 (2 x 700 mm dia.) - Bike and Garbage in the stream

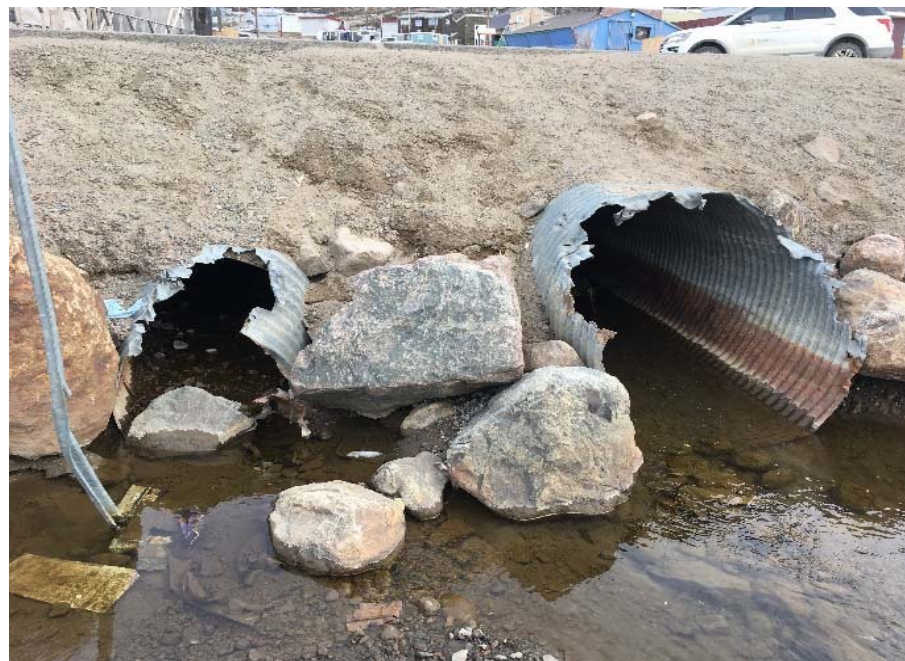
Downstream of Crossing 1 (2 x 700 mm dia.) -
Damaged and broken pieces

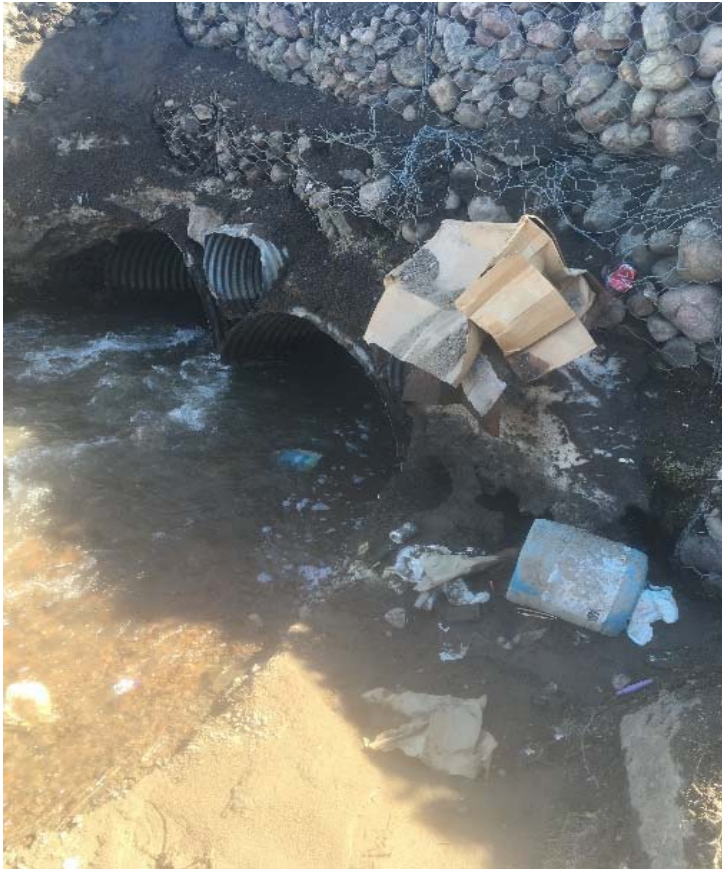
North of
Crossing 3 (3
x 1500 mm
dia. and 2 x
620 mm dia.)
-Garbage
right beside
the pipe

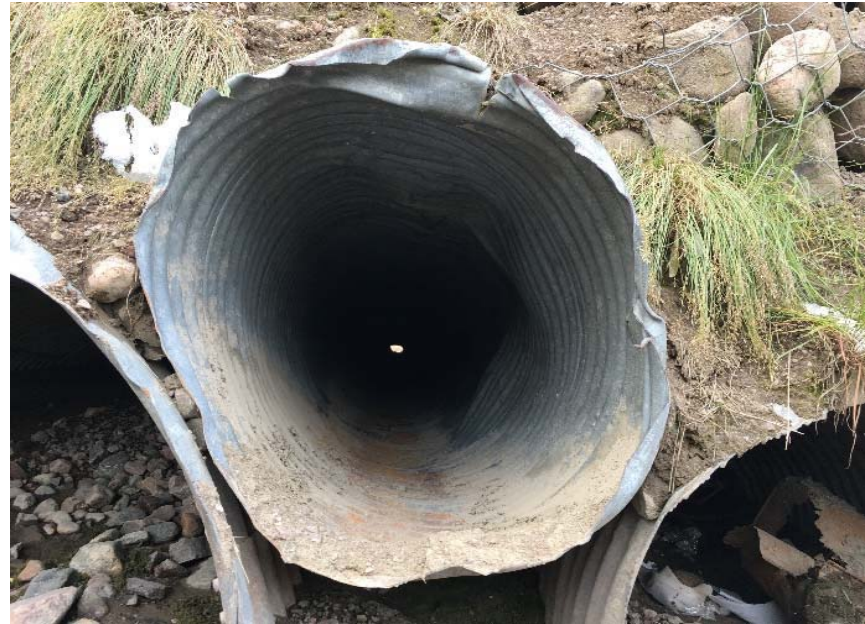
Upstream of Crossing 3 (2 x 1500 mm dia. and 1 x
620 mm dia.) -Deflected Pipe with damaged ends

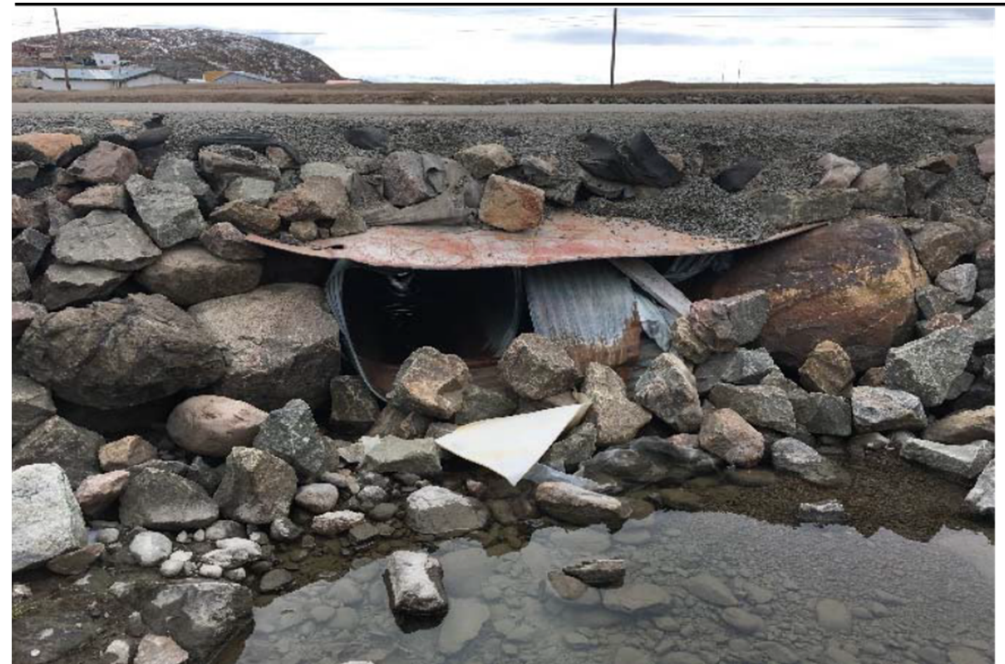
Cluster 1 of 4 Culverts (4 x 9400 mm dia.) on north
side of road - Garbage and broken pieces in front of
pipe

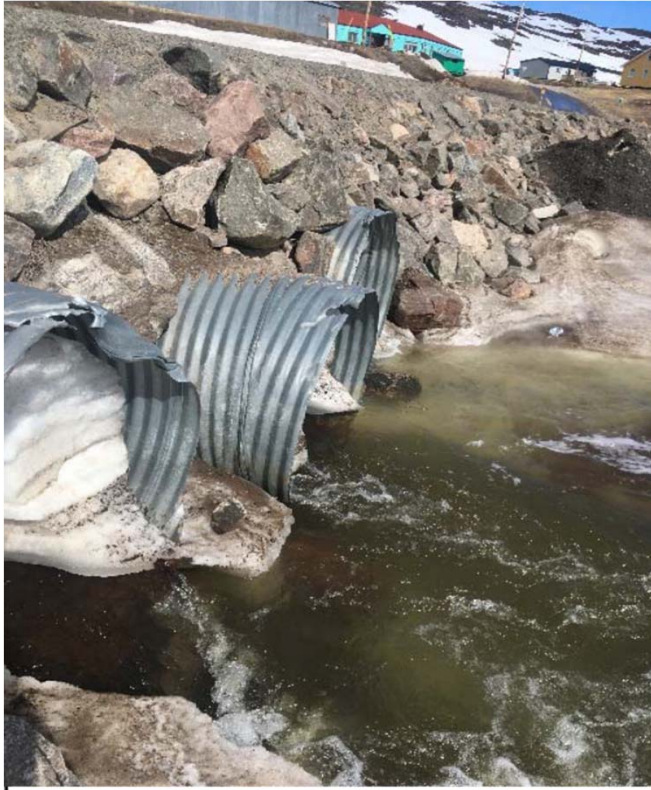
Cluster 2 of 3
Culverts (3 x
1100 mm
dia.) on south
side of road -
Blocked due
to snow

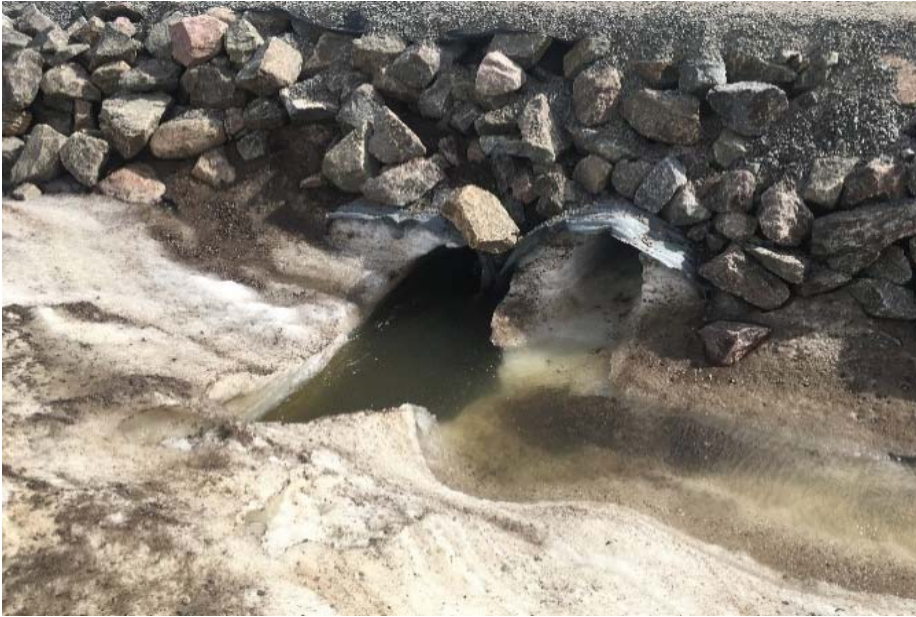
Cluster 1 (4 x 9400 mm dia.) taken from north side of road - Blocked due to snow
