CITY OF IQALUIT LAKE GERALDINE DAM VALVE CHAMBER REPLACEMENTS DRAFT REPORT

Iqaluit, NU

V&R Project No. 22-120
December 22, 2022

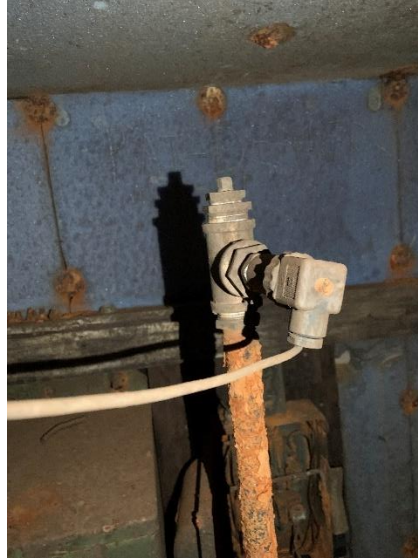
heading towards the water treatment plant. Given the condition of the services, it is assumed unlikely to be functioning properly.

Photo 2.1.3: top stem of assumed sensor

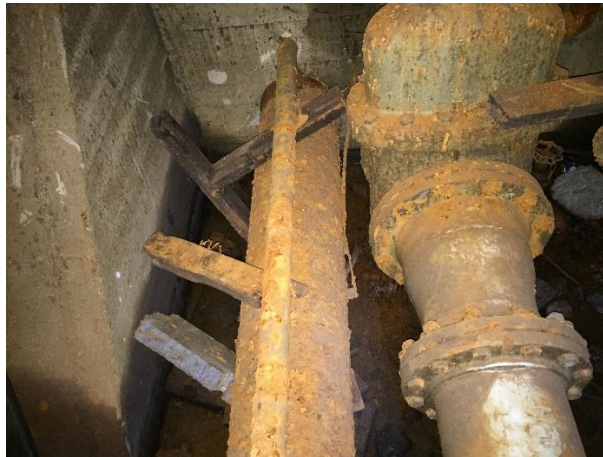
There are pieces of scrap material wedged between piping and the piping is resting on wooden blocks and rocks. No proper pipe supports were used.

Photo 2.1.4: example of scrap metal propping up piping

Once the temporary bypass is in place, the piping within the valve chamber can be removed. Electrical equipment should also be removed at this time, leaving feeds to serve new equipment. The valve chamber should be cleared of all loose rubble and scrap material and the ground should be levelled so that proper pipe supports can be installed.

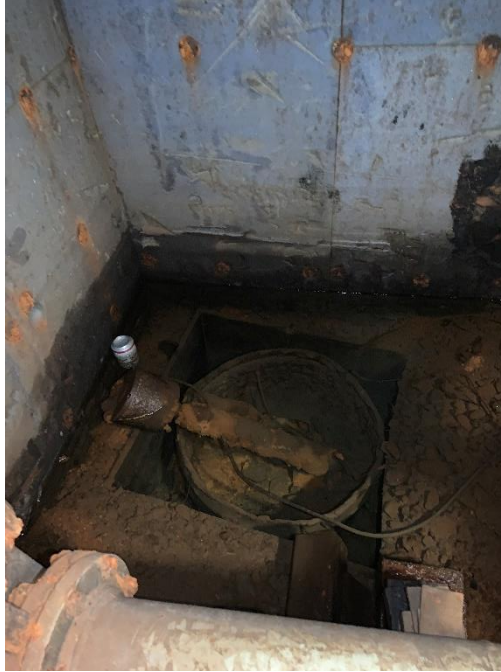
There is a pit within the valve chamber for what appears to be a pump. It is in a state of disrepair and no piping was noted as being connected to the system.

Photo 2.1.5: Sump pump and pit

A new sump pump system should be installed in the valve chamber to prevent excessive water levels within the structure.

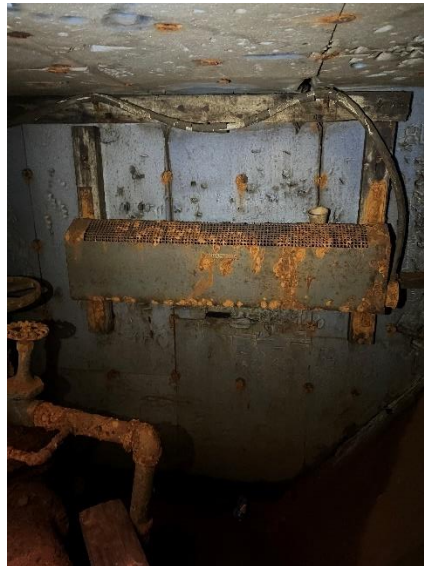
Electrical services, including switches and disconnects are mounted on the wall of the chamber and are also heavily damaged by corrosion. There is an electric heater mounted on the wall. It is not known whether this unit still functions.

Photo 2.2.1: existing electrical radiant heater

A new electrical radiant heater is recommended to maintain above freezing temperatures within the chamber.

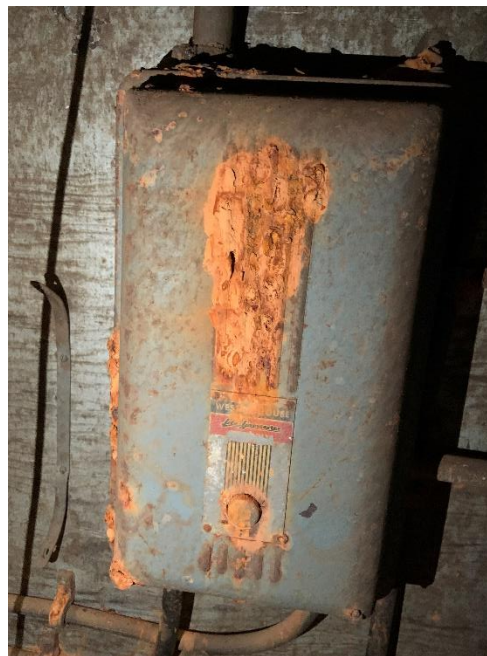
Photo 2.1.3: motor starter, assumed to be wired to sump pump

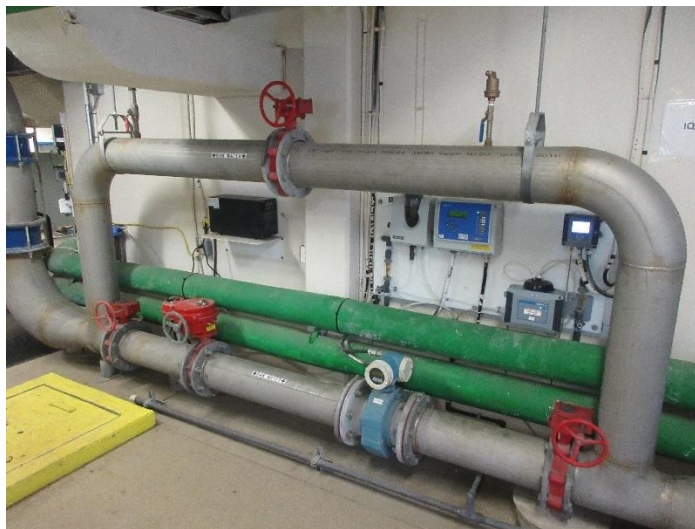
Photo 3.1: Proposed location for new RP backflow preventer

Since water treatment plants are considered a severe hazard application under CSA B64.10, a reduced pressure (RP) zone assembly backflow preventer should be installed on the intake piping; however, CSA indicated that RP assemblies cannot be installed in a vault. Backflow prevention should be installed within the water treatment plant.
