Our File No. 17-7406

September 6<sup>th</sup>, 2017

**Re: Astro Hill Bridge Iqaluit Condition Assessment**

Concentric was retained by the City of Iqaluit to complete a condition assessment of the Astro Hill Bridge located in Iqaluit, Nunavut. This submission outlines the results of the assessment.

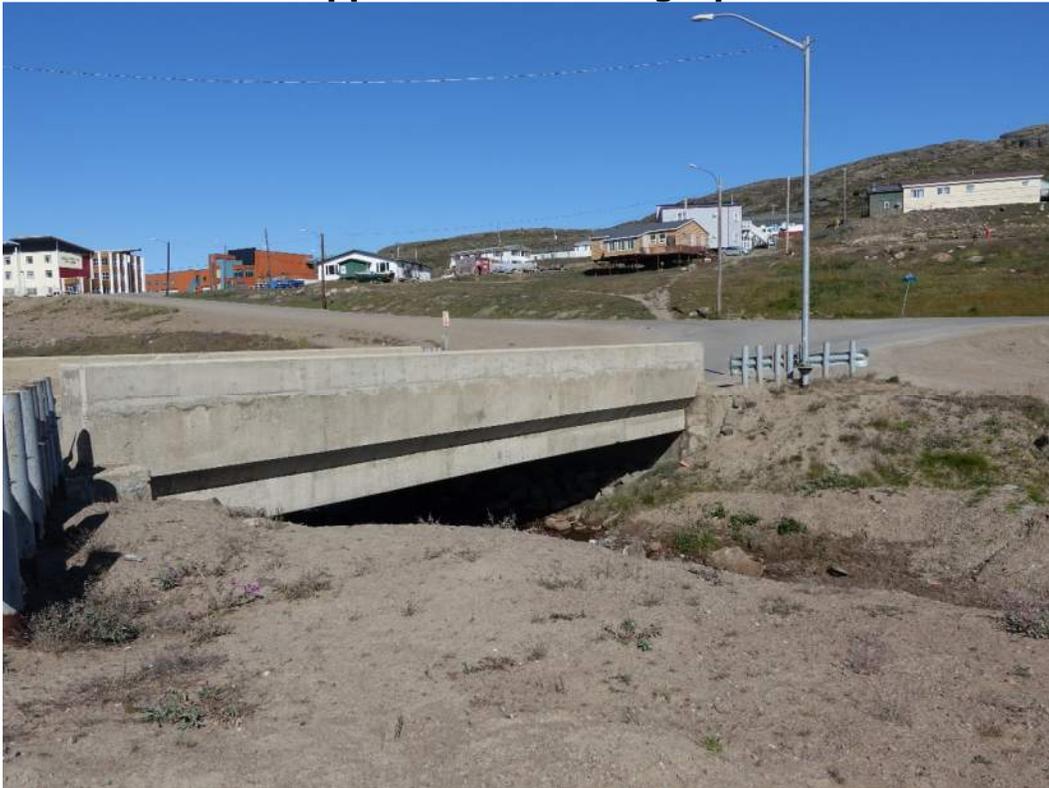
The Frobisher Bridge is a concrete bridge complete with concrete abutments, beams, and a concrete deck slab. The bridge has an overall length of approximately 13m with a clear span of 12.3m, see photograph 1 in Appendix. The width of the bridge is 9.5m, allowing two-way traffic.

**Photograph 1** – Overview of the Astro Hill Bridge

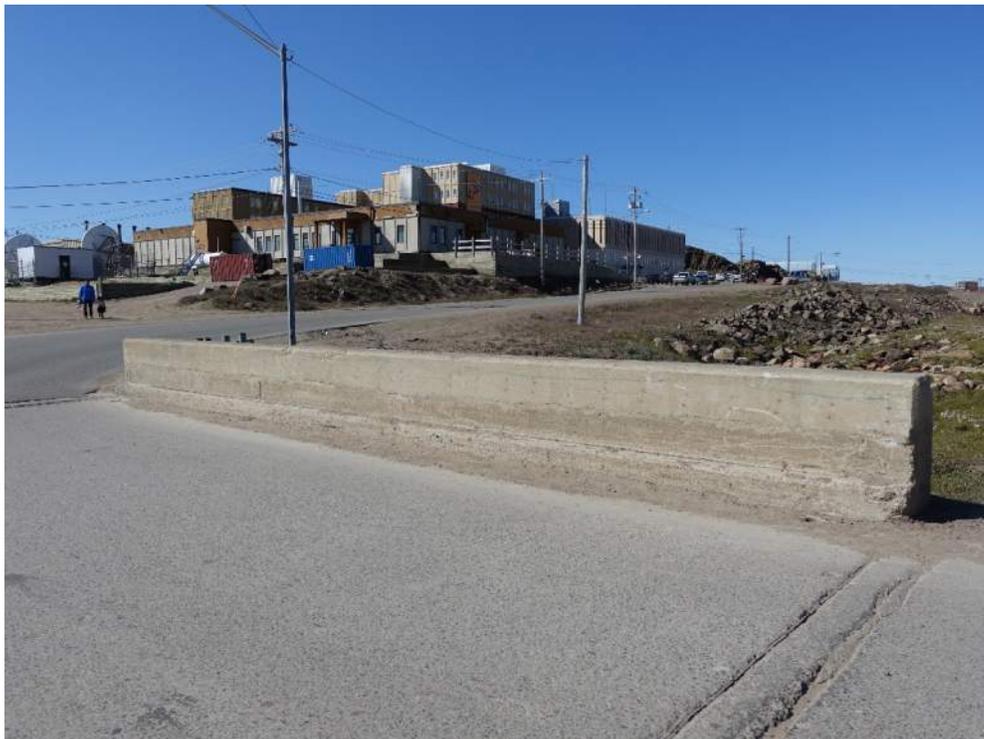
- The bridge was in fair condition overall.
- Several areas of chipped concrete were identified along the inside face of the concrete walls, likely caused by vehicular impact. See photograph 2 in Appendix.
- Localized horizontal cracking at the interface between an existing concrete patch and the original concrete was observed at the top of the east concrete abutment. See photograph 3 in Appendix.
- Exposed corroded reinforcing steel was observed at localized areas from beneath the bridge located on the underside of the concrete slab.
- Delamination and spalling was observed at localized areas on the underside of the north concrete beam. See photograph 4 in Appendix.
- Localized erosion of the granular fill was observed on the edge of the roadway approaches near the northwest, southwest and southeast corners of the bridge. See photograph 5 in Appendix.

**Photograph 2** – Localized damage of the concrete curb/ wall

- Localized repairs of the concrete curbs (approximately 20m).
- Localized repairs of the concrete abutments (approximately 3m<sup>2</sup>).
- Localized repairs of concrete beams (approximately 4 m<sup>2</sup>).
- Further engineered fill or better will likely again be required at roadway approaches.

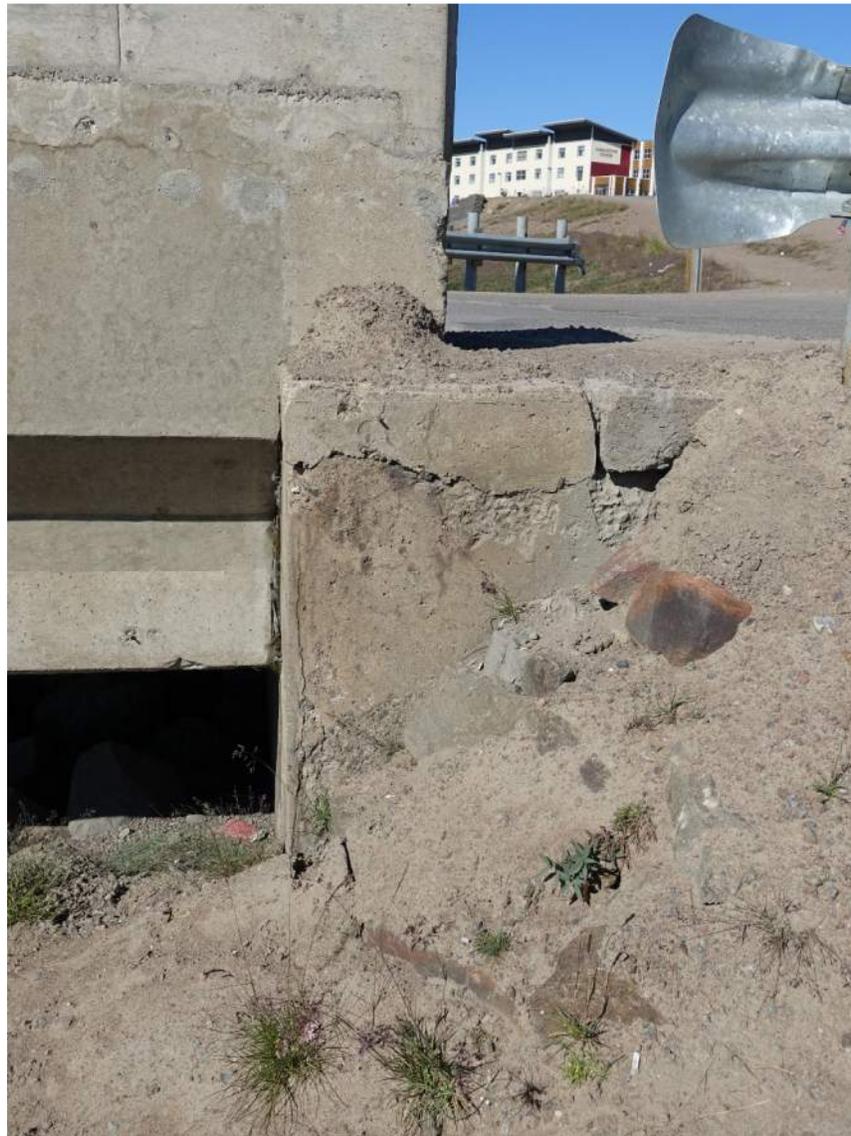
**Photograph 3** – Localized cracking and spalling of concrete abutment. Soil erosion was also noted.

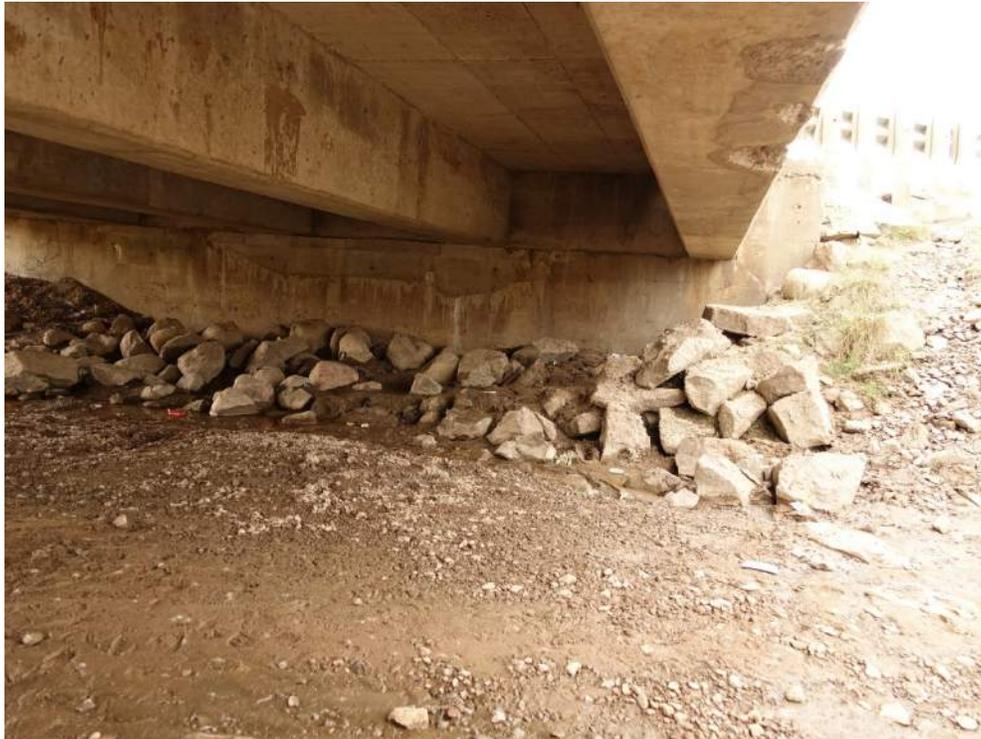
**Photograph 4** – Localized delamination of north concrete beam.

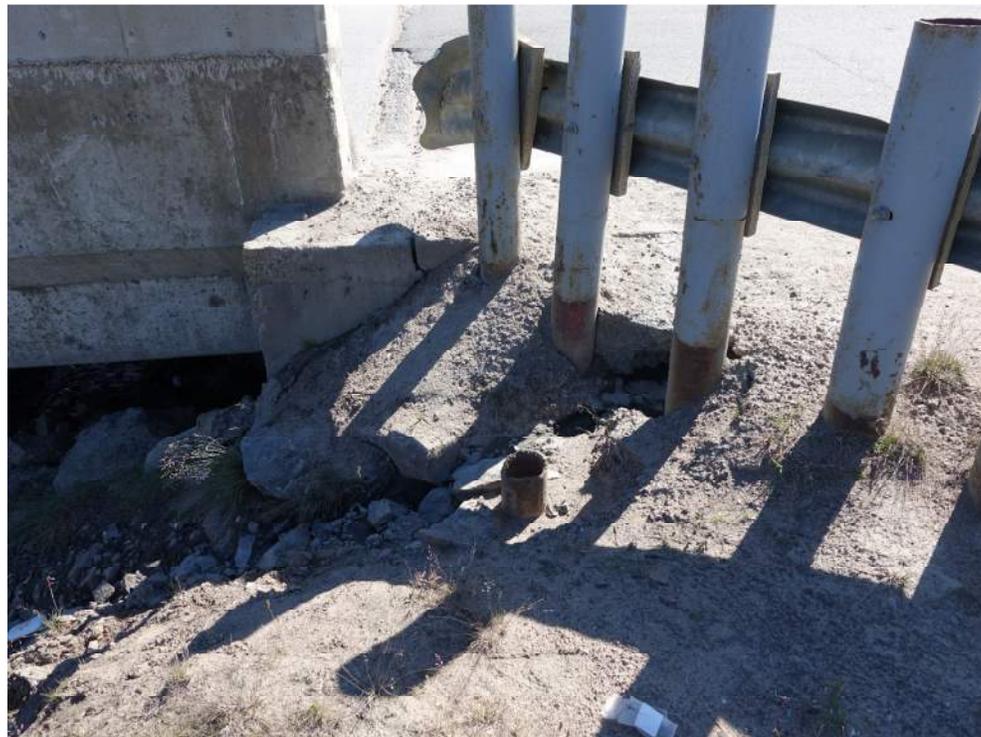
**Photograph 5**- Localized washout at abutment, typical.

- Supplementary engineered fill is required on the edge of the roadway approaches near the northwest, southwest and southeast corners of the bridge to combat the localized granular washouts.
