Our File No. 17-7406

September 6th, 2017

Re: Apex Bridge Iqaluit Condition Assessment

Concentric was retained by the City of Iqaluit to complete a condition assessment of the Apex Bridge located in Iqaluit, Nunavut. This submission outlines the results of the assessment.

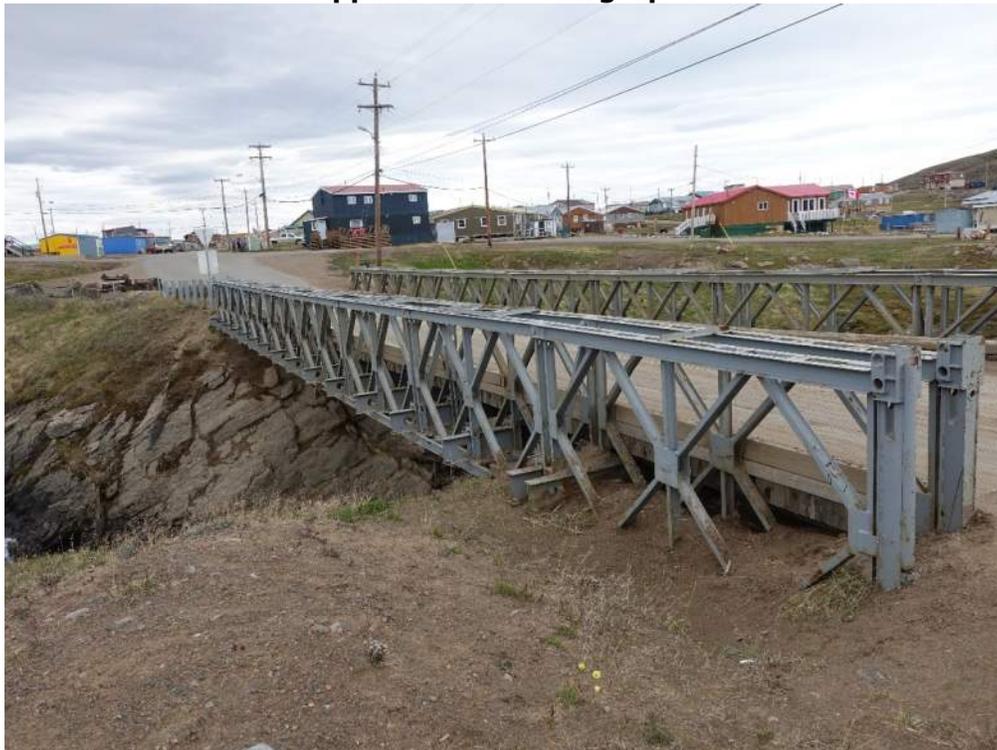
Photograph 1 – Overview of Apex Bridge structure.

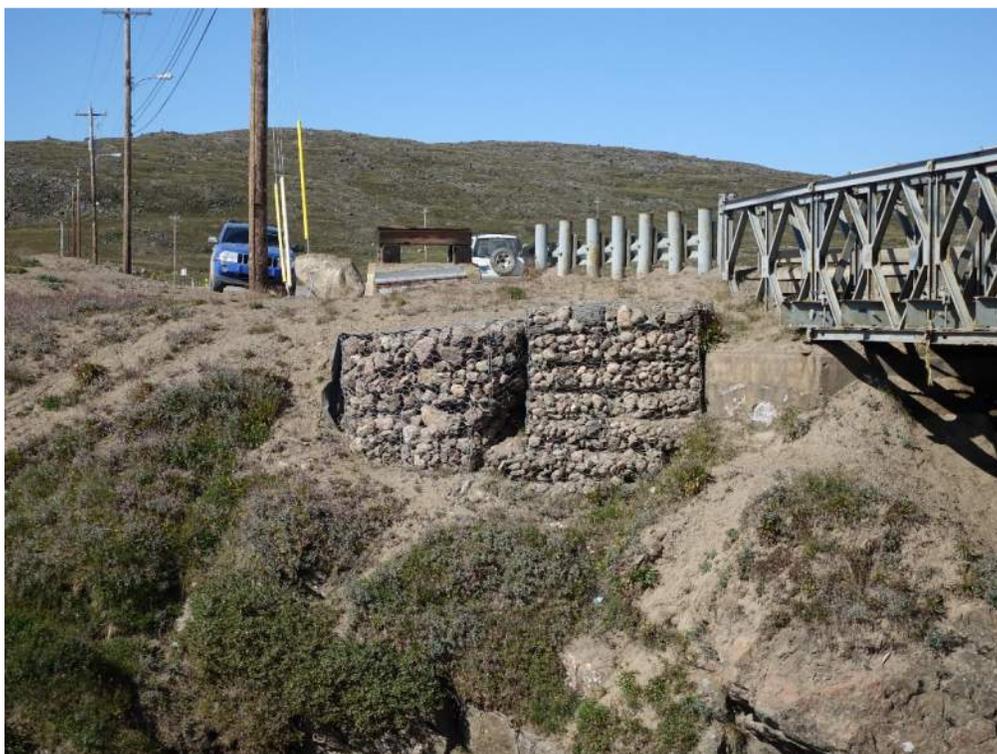
- The bridge was in fair to poor condition.
- Erosion of soil was observed at the northwest and southwest corners of the bridge.
- Erosion of soil around the gabion baskets at the northwest abutment was observed. See photograph 2 in Appendix.

Photograph 2 – Erosion around the gabion baskets at the north-west abutment.

- The timber deck's top wear course should be replaced.
- The lock pins should be replaced at all locations where they are missing or have the incorrect lock pin (nails, bolt, etc).
- The stability of the gabion baskets at the northwest abutment should be restored. This will likely require installation of supplemental gabion baskets.
- The missing transom locks on both sides of the bridge should be replaced.
- Replace the missing horizontal bracing frames at the north end of the bridge to match the original configuration.
- The damaged vertical truss members that have been locally reinforced should be removed and replaced with new to match the original configuration.
- Damaged guardrails should be repaired/ replaced.
- The steel structure should be abrasive blast cleaned to remove corrosion and the entire structure should be recoated.

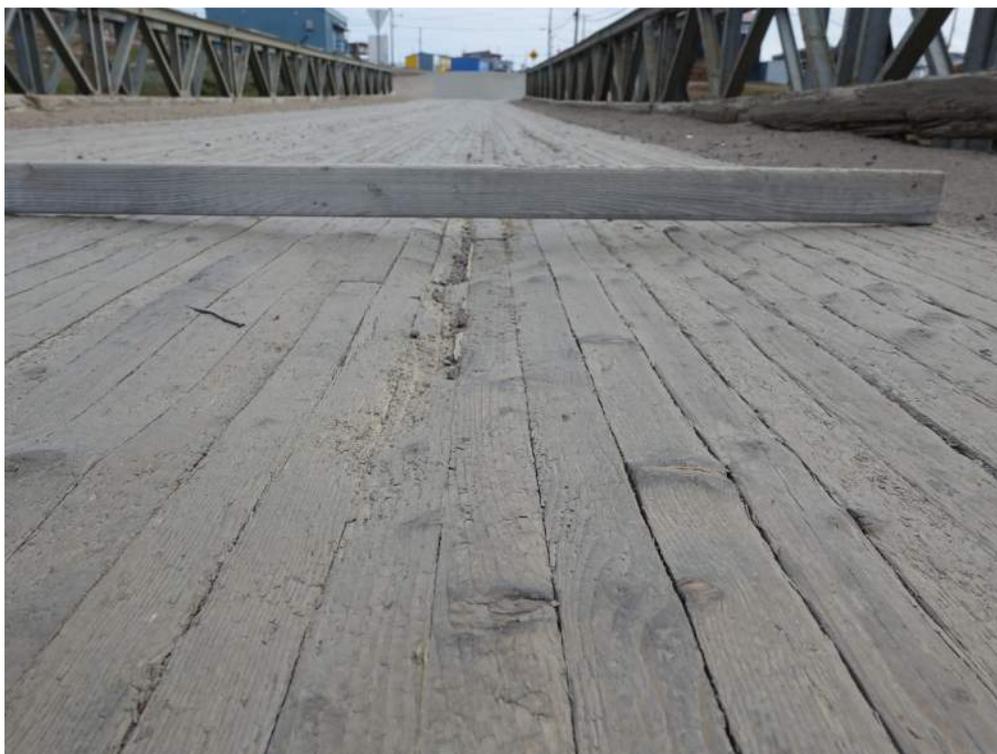
- The timber deck had eroded along the path of vehicle tires. Wear of the timber deck and exposed bolts/nails were observed. See photograph 3 in Appendix.

Photograph 3 – Wear of the timber deck – note the exposed nail.

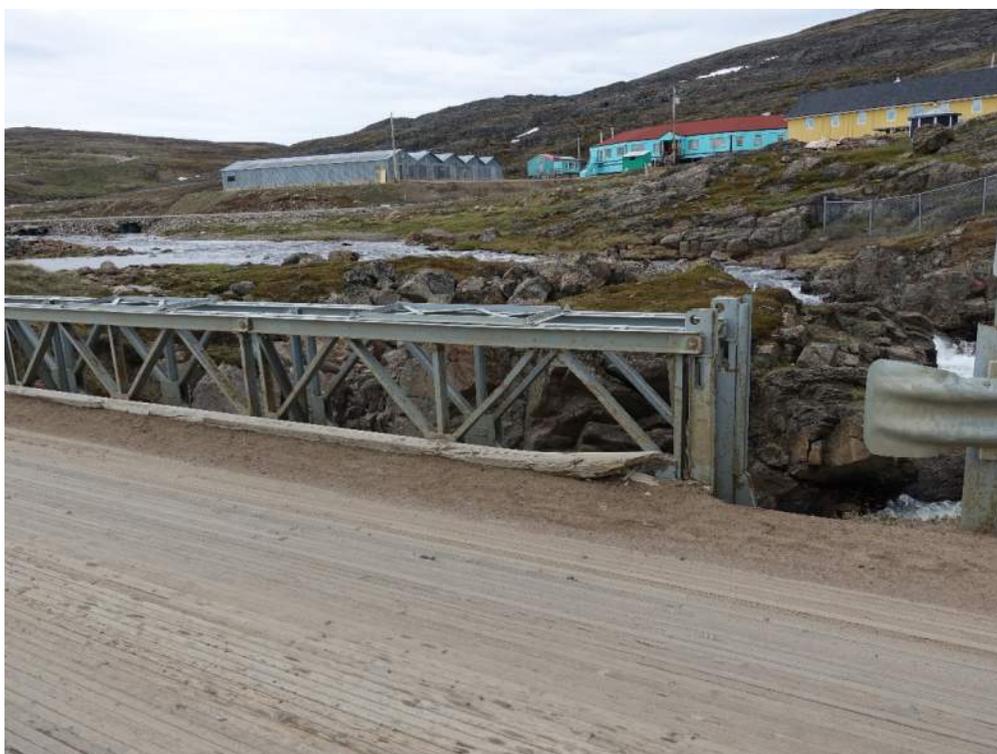
- The wood curb on either side of the bridge was in poor condition. See photograph 4 in Appendix.
- The majority of panel pins did not have the correct lock pins used. A variety of nails, bolts, and cotter pins were used instead of the 3/16" pins used during original construction. See photograph 5 in Appendix.

Photograph 4 – Damaged wood curb on the east side of the bridge.

- Supplementary engineered fill is required on the edge of the roadway approaches near the northwest and southwest corners of the bridge to combat the localized granular washouts.
- The wood curbs on either side of the bridge are in poor condition no longer functioning as intended and should be replaced. The curbs help protect the bridge from vehicle impact and future damage.
- The damaged and missing bolts used to fasten the horizontal brace frames on top of the structural frames should be replaced.

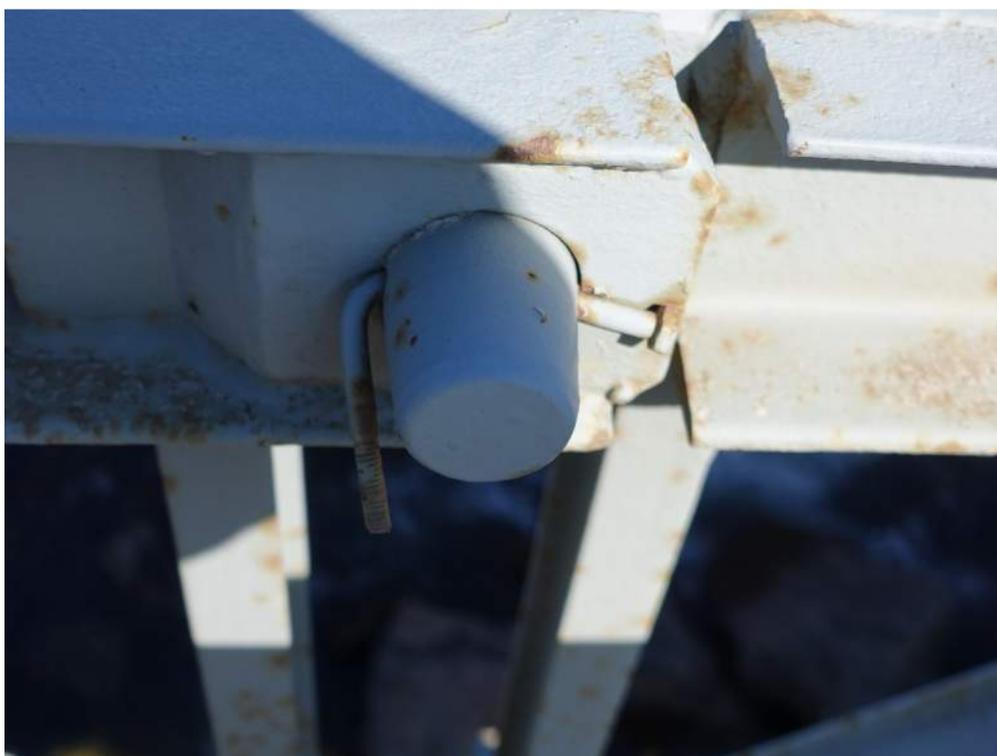
Photograph 5 – Incorrect lock pin used in the panel pin.

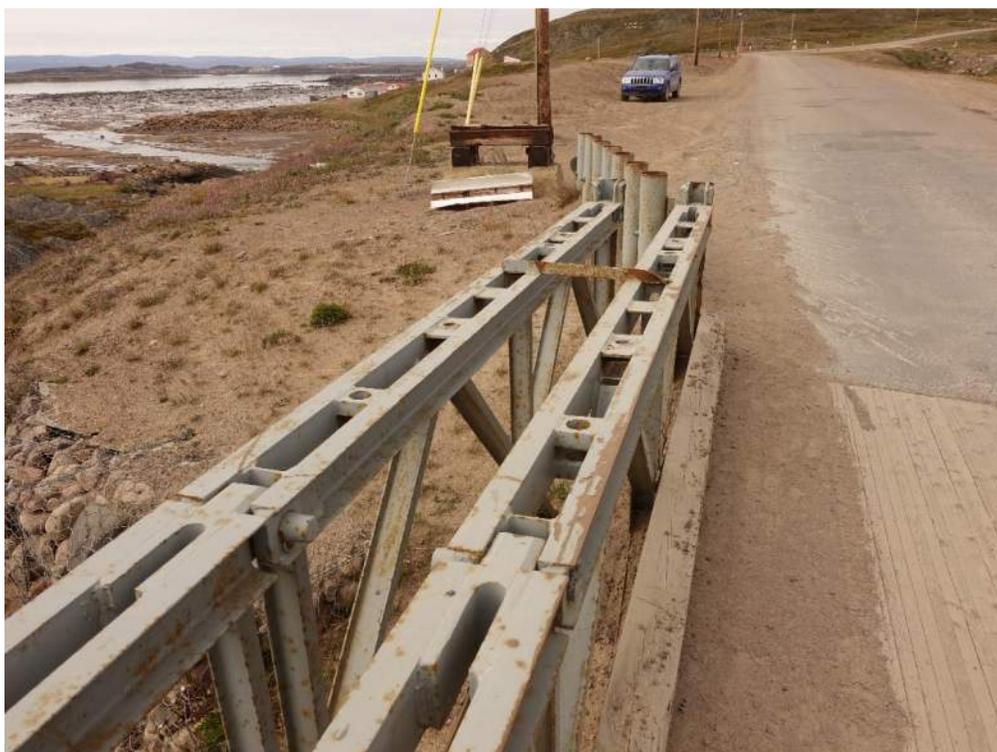
- Two of the horizontal bracing frames were missing at the north end of the bridge and were replaced with a steel angle welded in place. See photograph 6 in Appendix.

Photograph 6 – Missing horizontal bracing member at north end of the bridge.

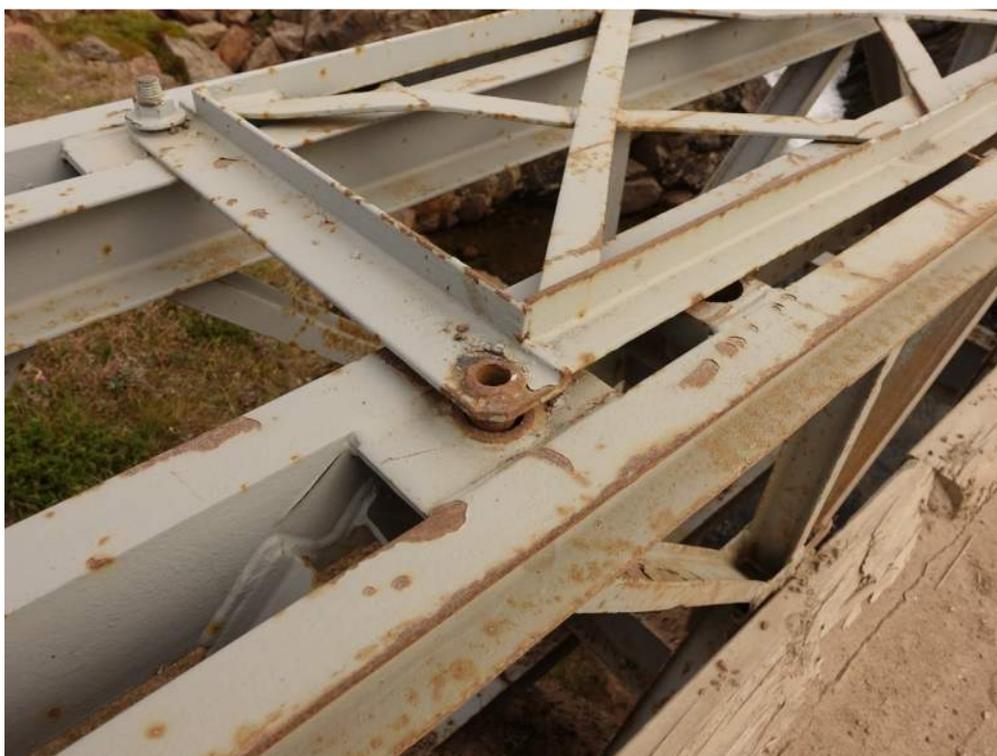
- One (1) horizontal bracing member on either side of the bridge had a bolt missing, while two (2) bolts on the east side were damaged due to impact. See photograph 7 in Appendix.

Photograph 7 – Missing bolt in the horizontal bracing member.

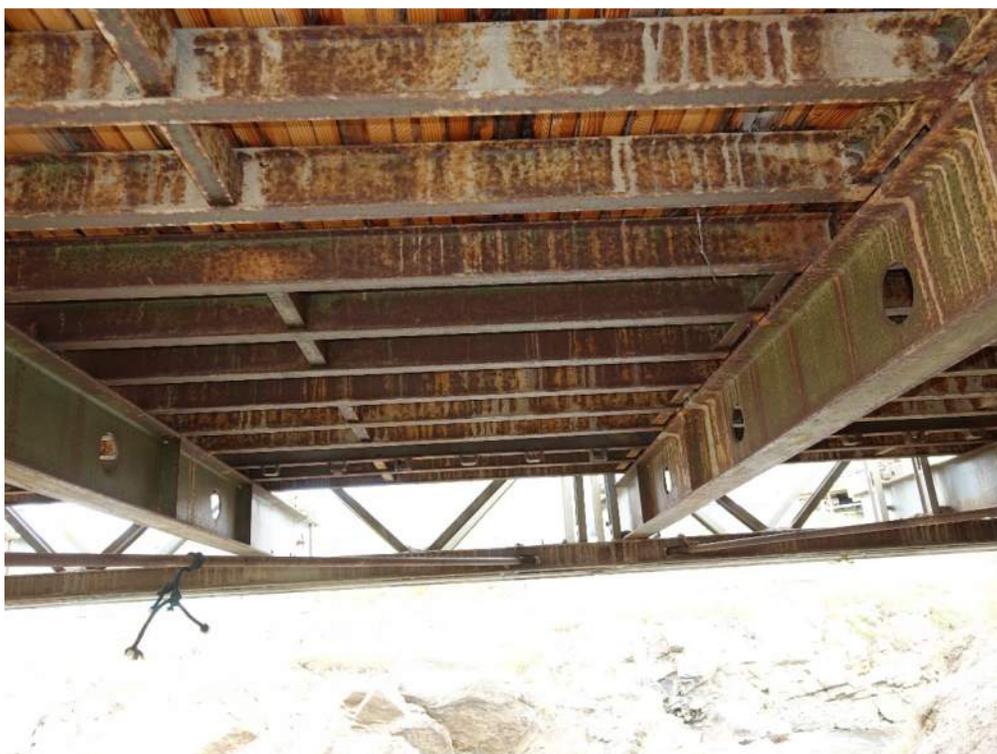
- The coating on all steel members has failed and allowing corrosion of the steel to develop. The steel below the bridge deck appears to have the most advanced development of corrosion. See photograph 8 in Appendix.

Photograph 8 – Corrosion on steel framing below the timber deck.

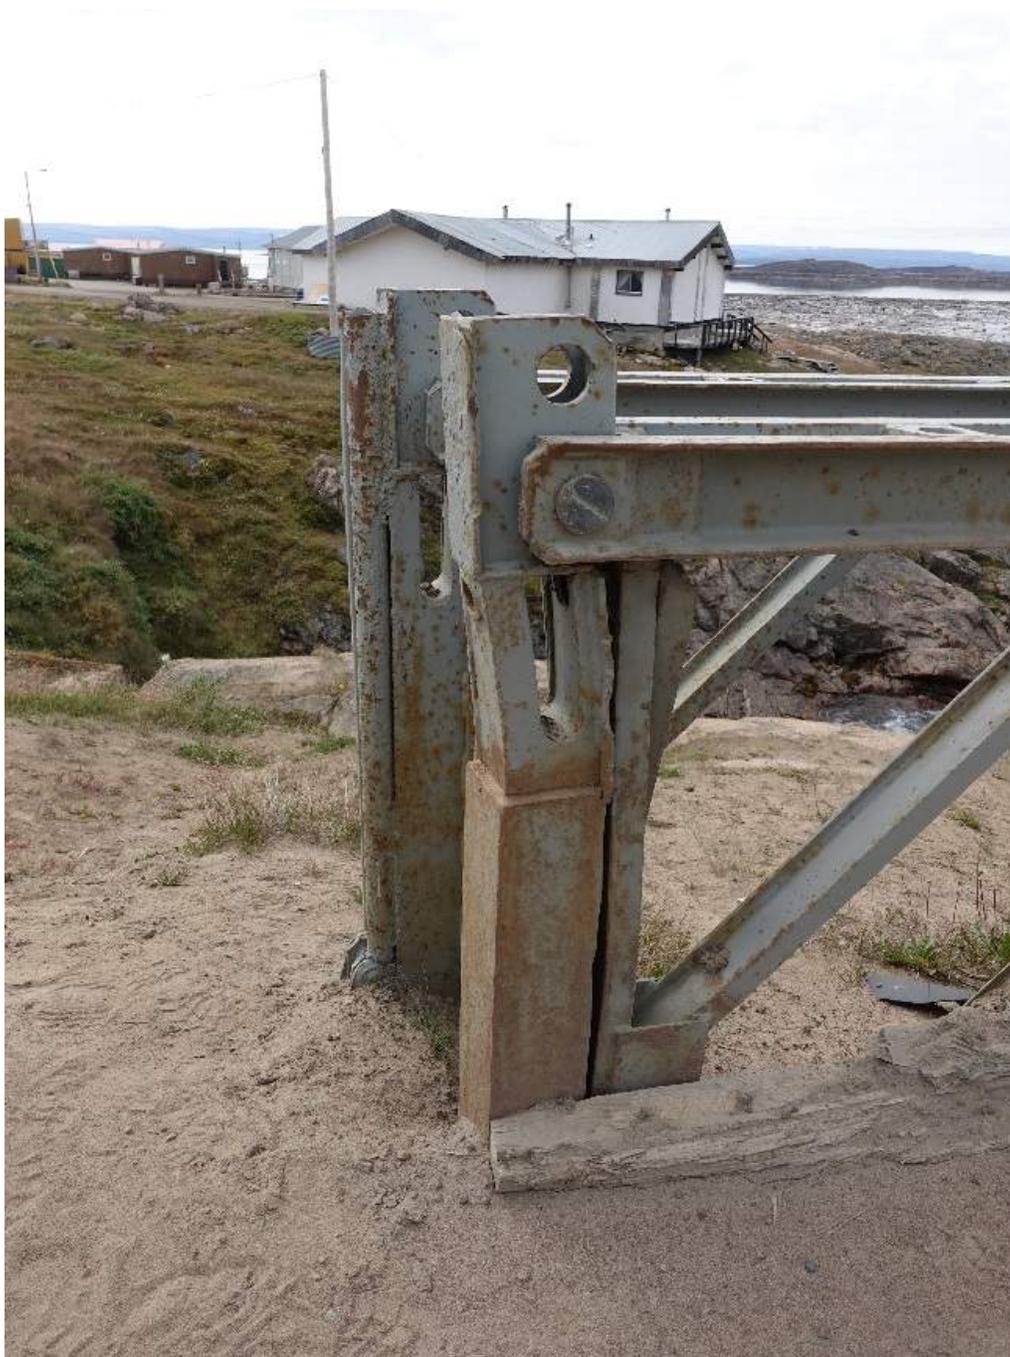
- The vertical member of the truss at the southwest corner was damaged by a vehicular impact in 2006 and a repair design was detailed in 2010. The repaired member differs from the design. See photograph 9 in Appendix.

Photograph 9 – Damaged vertical member that has been repaired.
The repair differs from the design detailed in 2010.

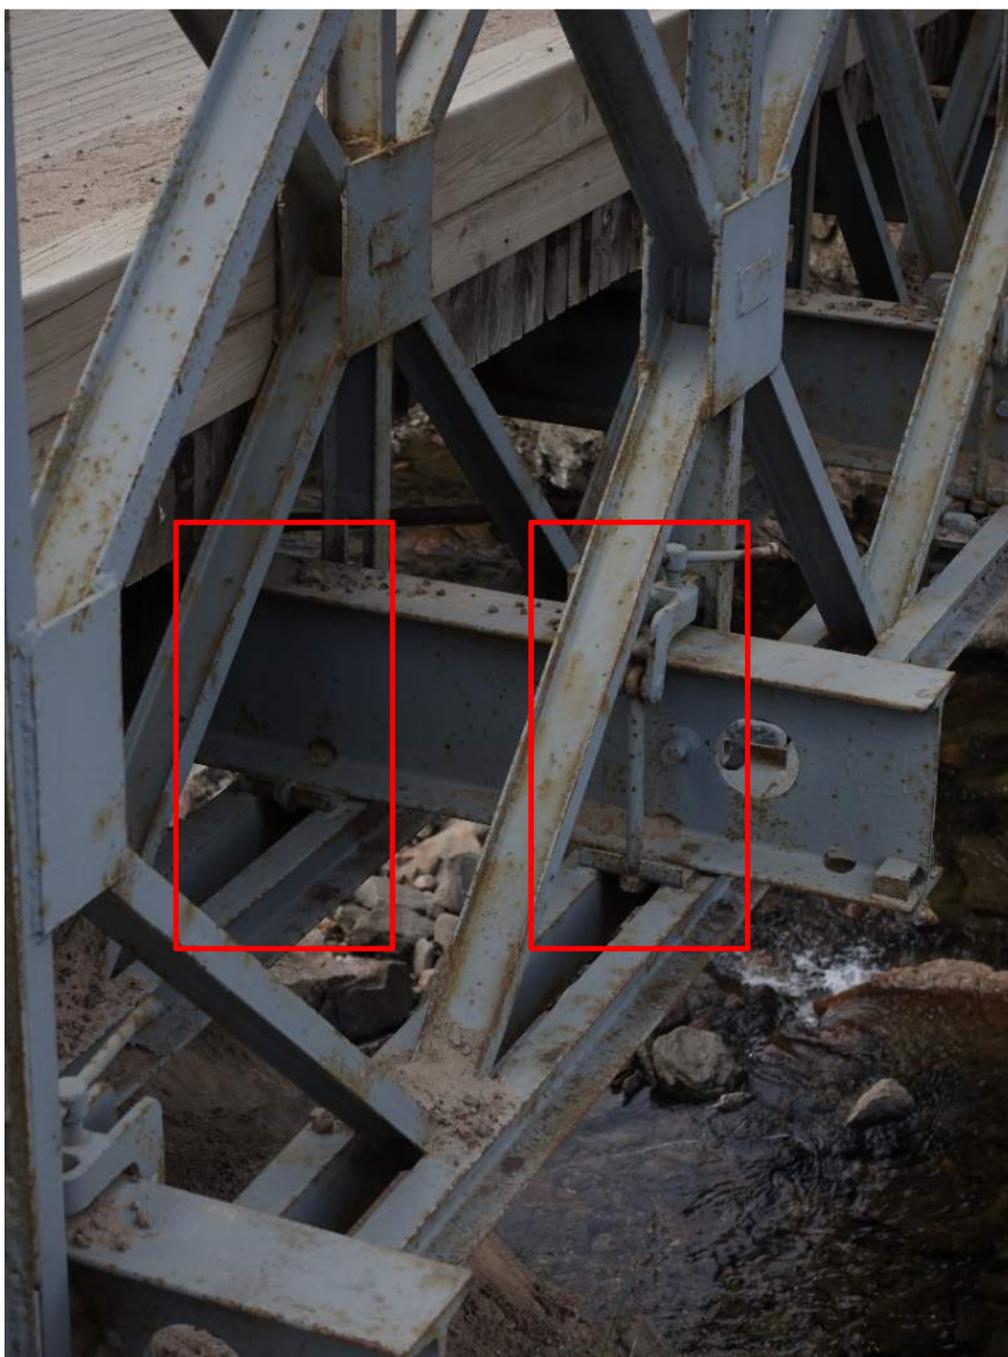
- The guard rail at the southwest corner was damaged by a vehicular impact.
- It was noted that several transom locks were missing on both sides of the bridge (five (5) on the west side and six (6) on the east side). See photograph 10 in Appendix.

Photograph 10 – Missing transom lock on the interior truss (left).
Note the transom lock in view on the exterior truss (right).
