City of Iqaluit
Master Drainage Plan

Workshop #1

Workshop #2

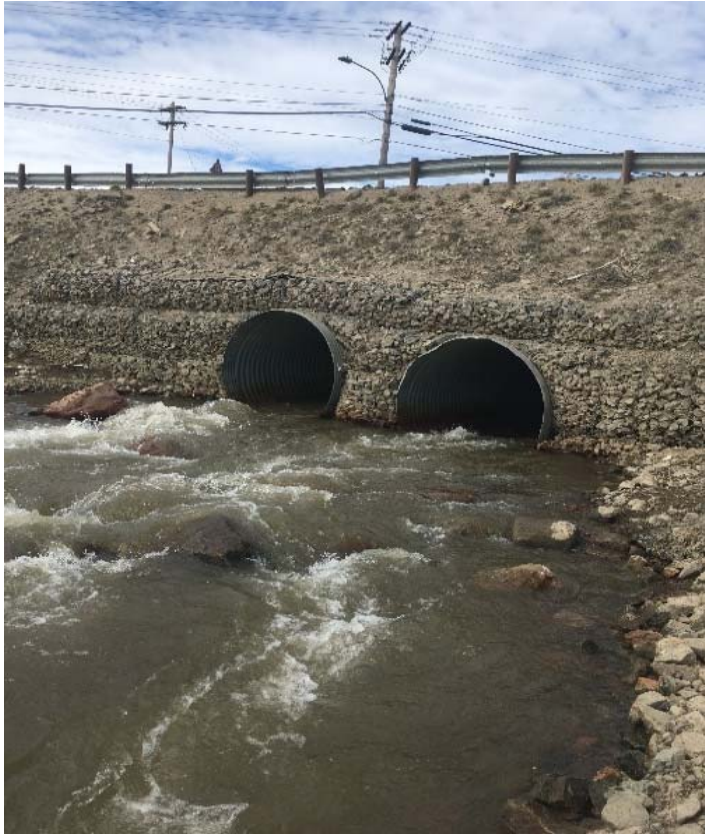
South of crossing 1 (2x 1800 mm dia.) – Early Spring Meltoff

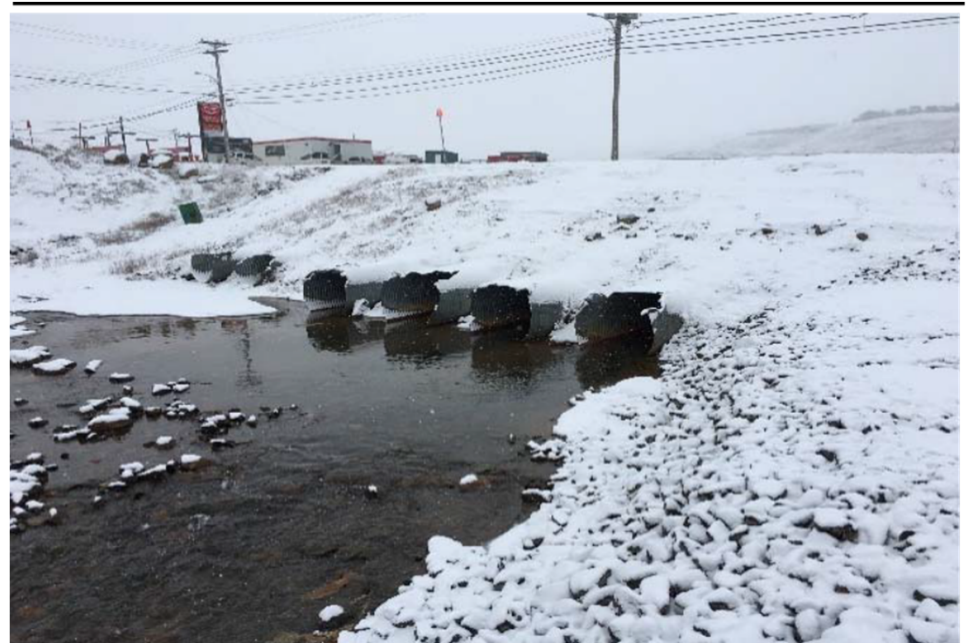
South of Crossing 3 (4 x 1200 mm dia. and 2 x 1000 mm dia.) - Early Fall

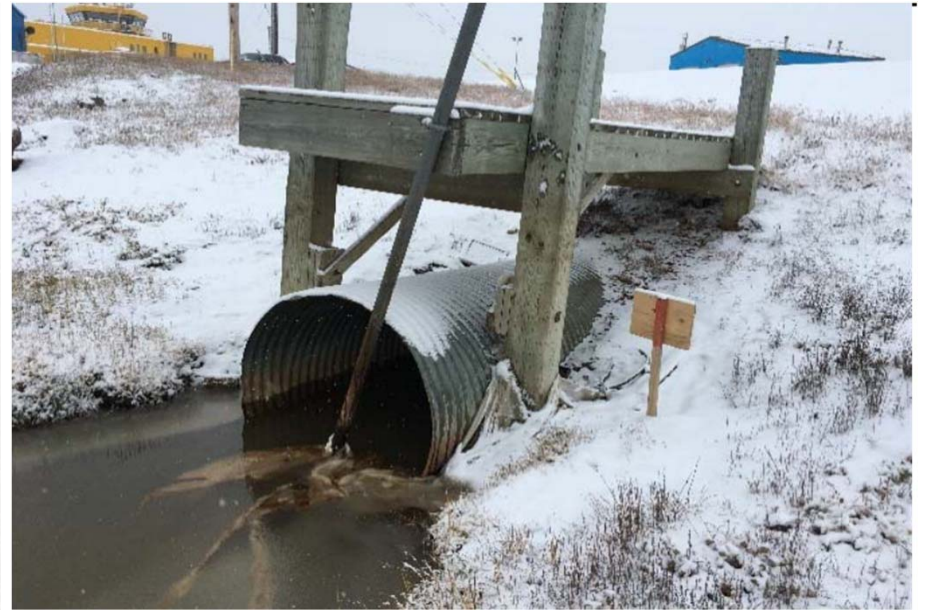
East of Crossing 6B (600 mm dia.) -Appears to be garbage in the stream

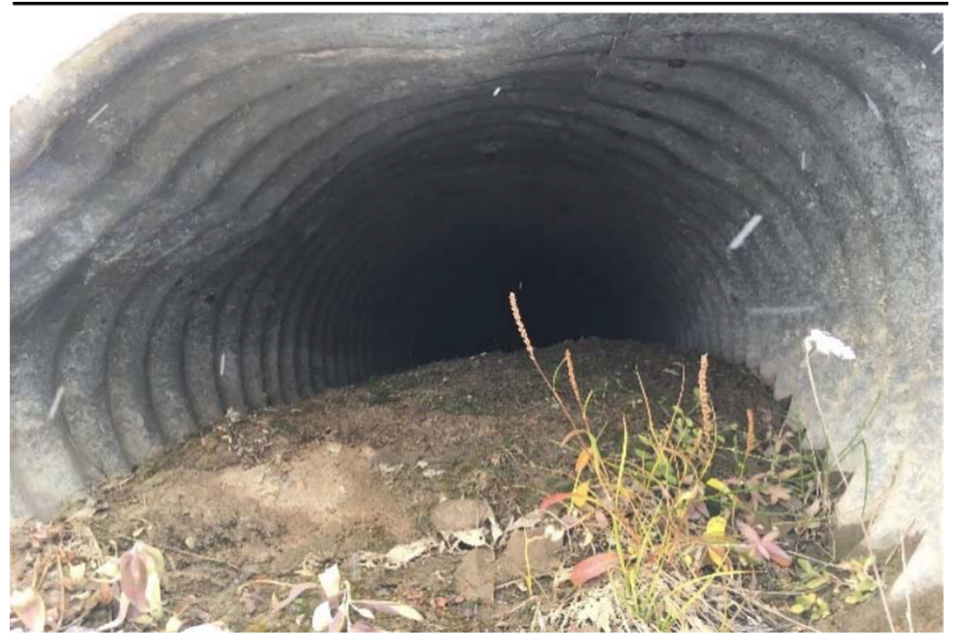
South of Crossing 7 (600 mm dia.) -Sediment buildup in the pipe

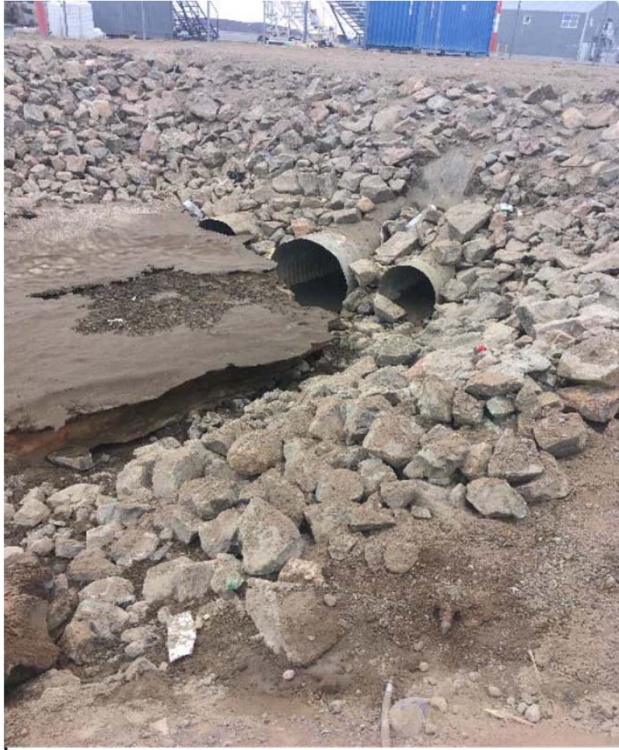
East of
Crossing 8 (2
x 1000 mm
dia. and 1 x
1600 mm
dia.) -Snow
about to melt

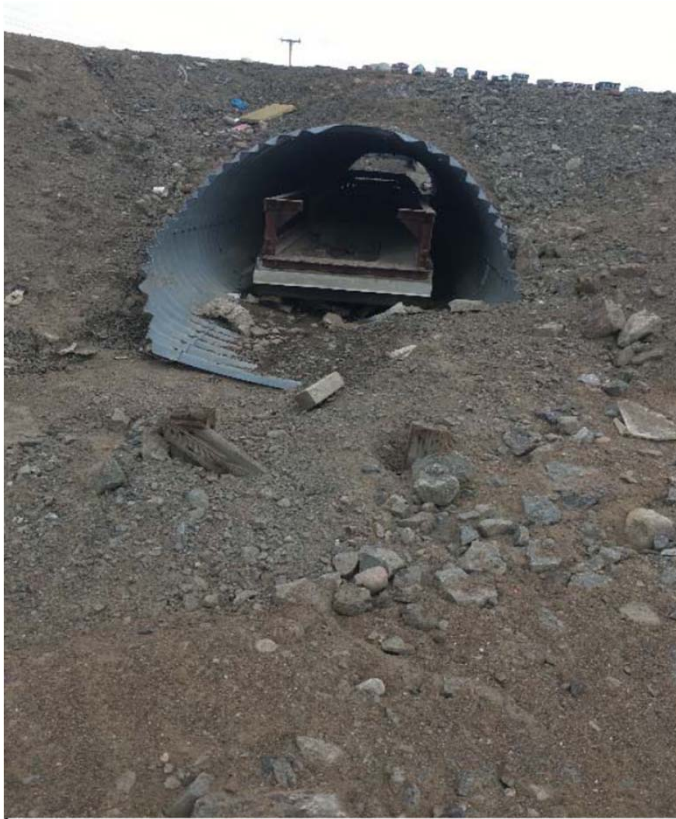
West of
Crossing 9
(2100 mm
dia.) -
Furniture
inside the
pipe

X9	NE	SW	2100	Corrugated Steel	Circular	Projected	N	Torn out edges, significant amount of debris deposited at the upstream end. A furniture was identified in the Culvert	
X10a	NW	SE	3100	Corrugated Steel	Arch	Projected	N	Garbage deposits at the upstream end	
X10b	NW	SE	1600	Corrugated Steel	Circular	Projected	N		
X12a	N	S	1000	Corrugated Steel	Circular	Projected	N	Deformed Culvert, elliptical in shape, surface corrosion on floor	
X12b	N	S	1000	Corrugated Steel	Circular	Projected	N	Worn Out Edges, surface corrosion on floor	
X12c	N	S	1000	Corrugated Steel	Circular	Projected	N	Surface corrosion on floor	
X12d	N	S	2100	Corrugated Steel	Circular	Projected	N	Deformed Culvert, deflected sidewall at 2 O'clock, at the downstream end.	
X13	NW	SE	1600	Corrugated Steel	Circular	Projected	N	Deteriorated Edges at the downstream end

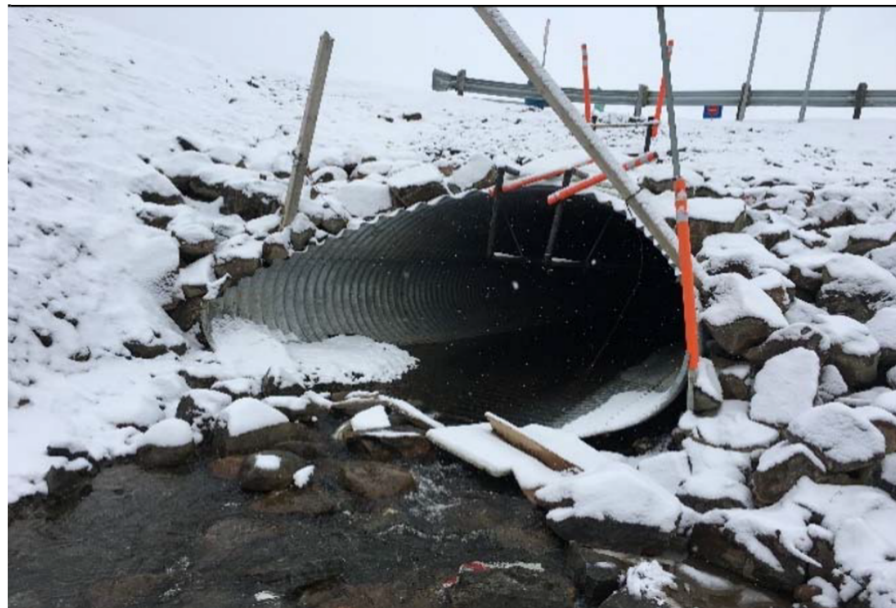
East of Crossing 10 (3100 mm dia.) -Deflected Pipe

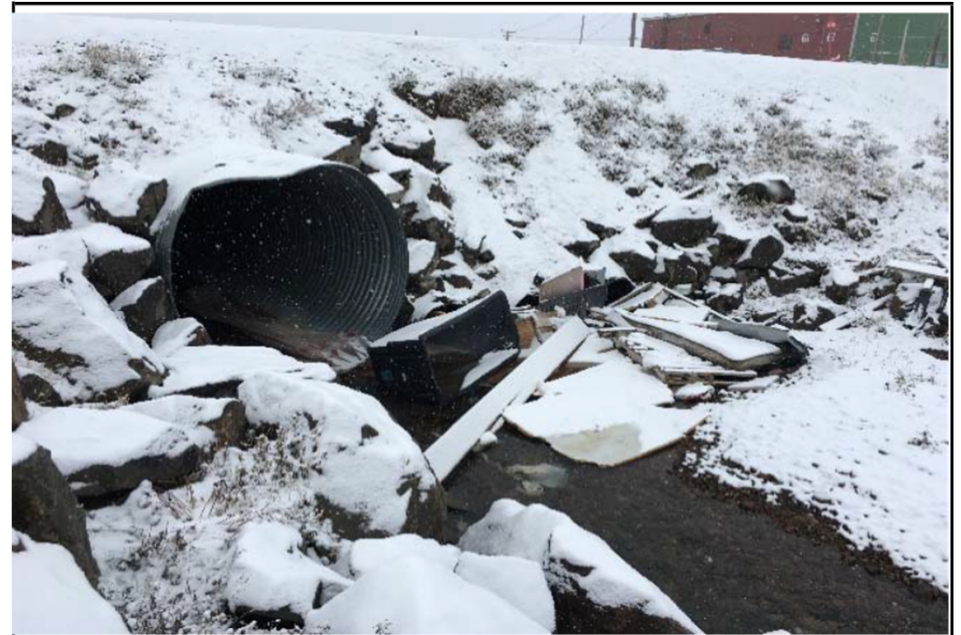
North of Crossing 12 (3 x 1000 mm dia. and 1 x 2100 mm dia.) looking
Upstream -Garbage buildup infront of pipe

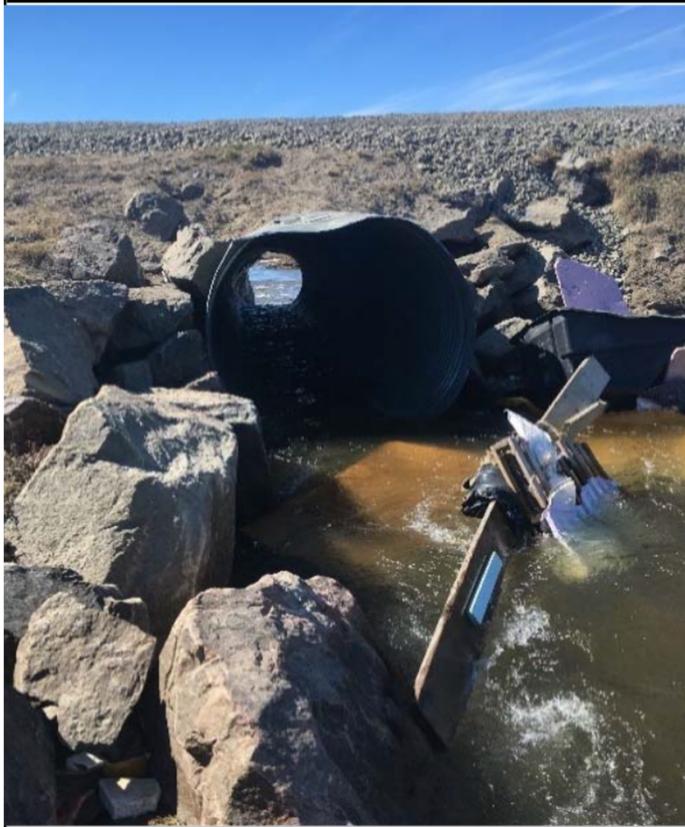
North of
Crossing 12 (3
x 1000 mm
dia. and 1 x
2100 mm
dia.) -
Garbage in
the stream

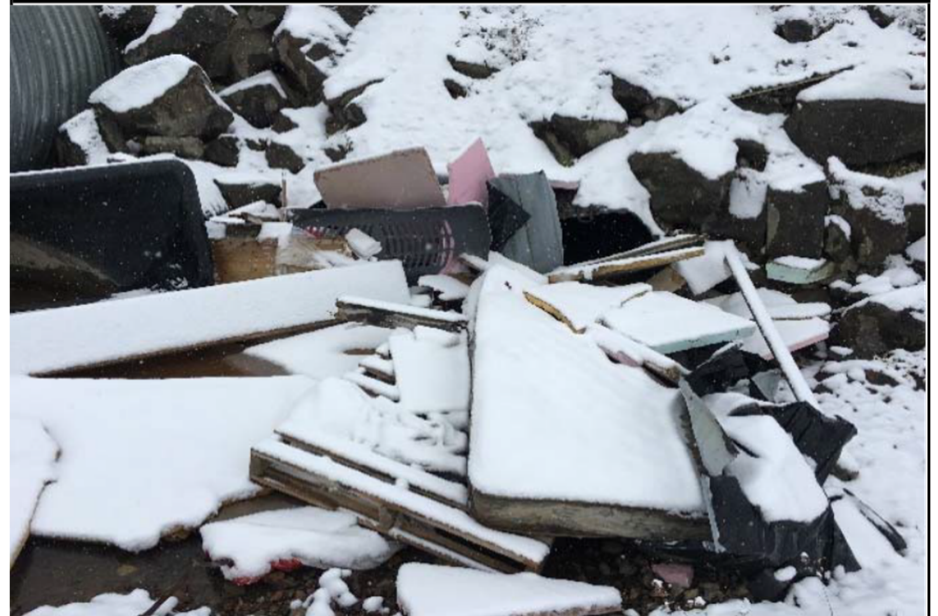
North of Crossing 12 (3 x 1000 mm dia. and 1 x 2100 mm dia.) looking
Upstream -Wooden Pallets and Garbage

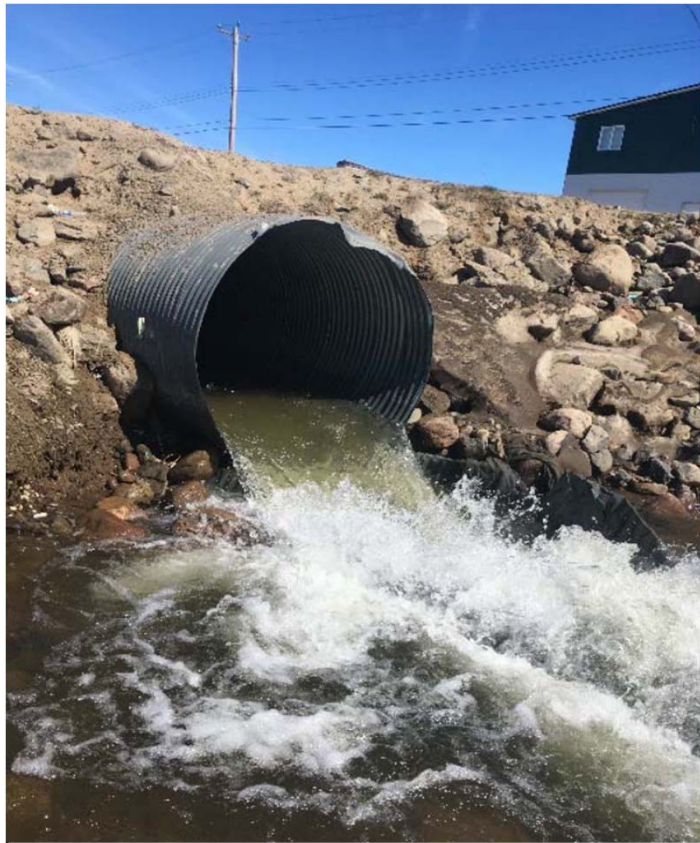
East of
Crossing 13
(1600 mm
dia.)

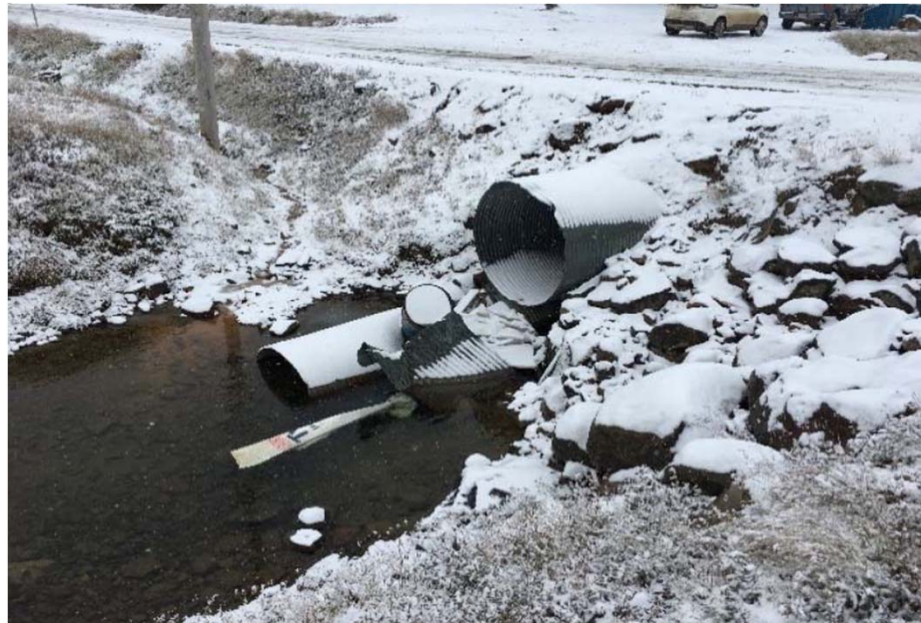
East of Crossing 13 (1600 mm dia.) looking
Downstream -Garage in the stream

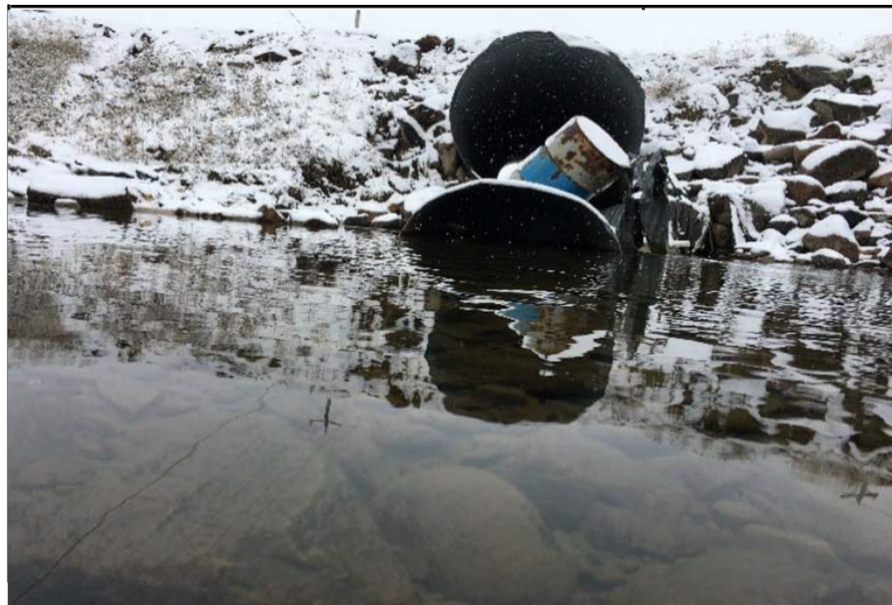
East of Crossing 13 (1600 mm dia.) looking Downstream -Barrel
inside the pipe, probably received during the stream flow

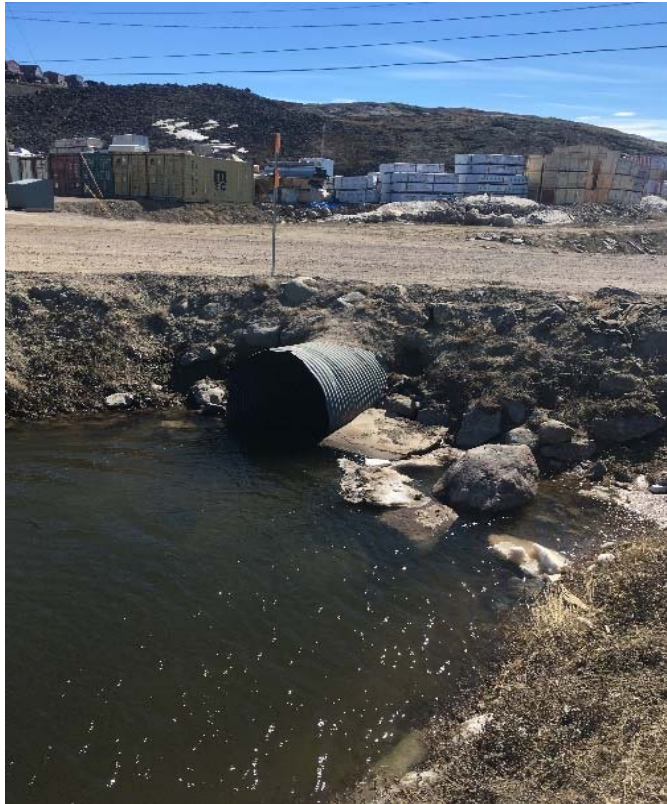
East of Crossing 13
(1600 mm
dia.)

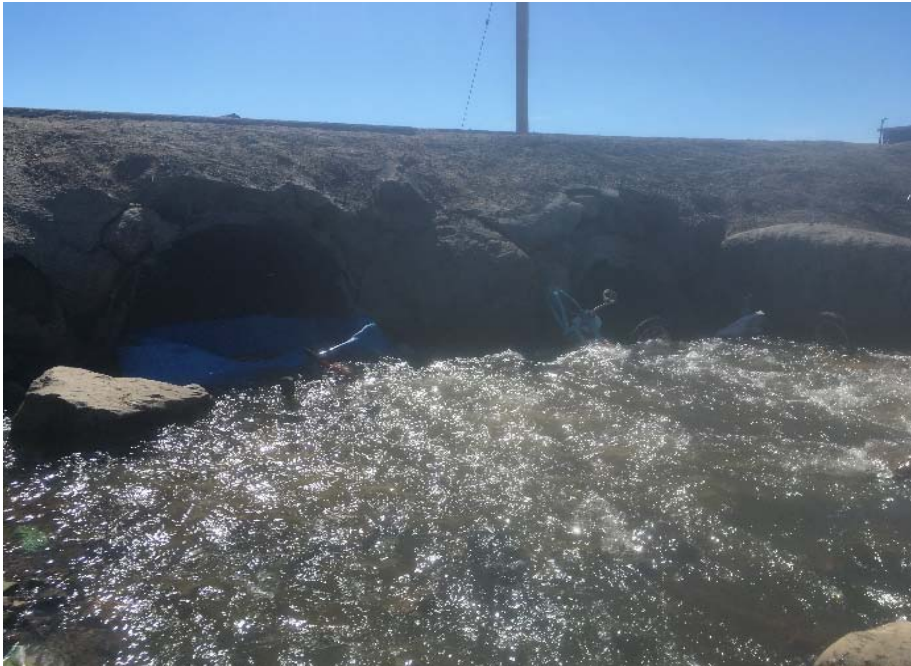
North of Crossing 1 (2 x 700 mm dia.)

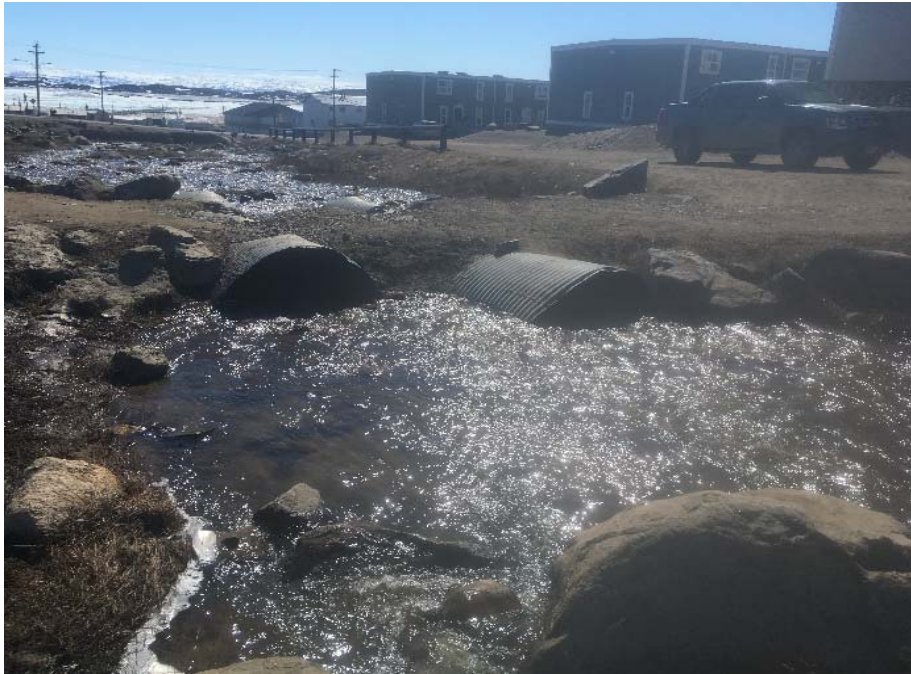
Crossing 4 (2 x 1350 mm dia.) looking South

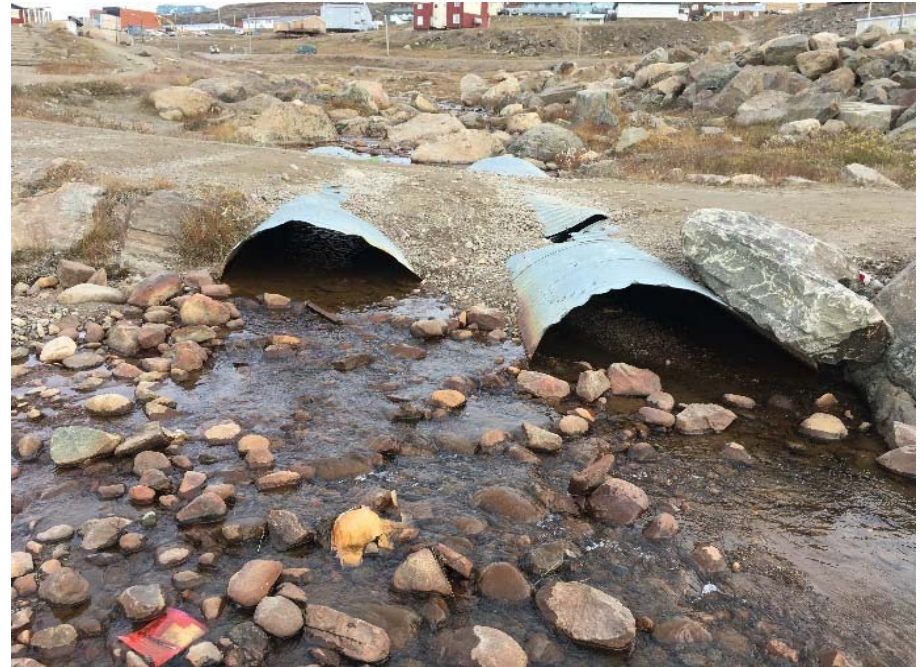
Downstream of Crossing 4 (2 x 1350 mm dia.) -
Garbage in the stream

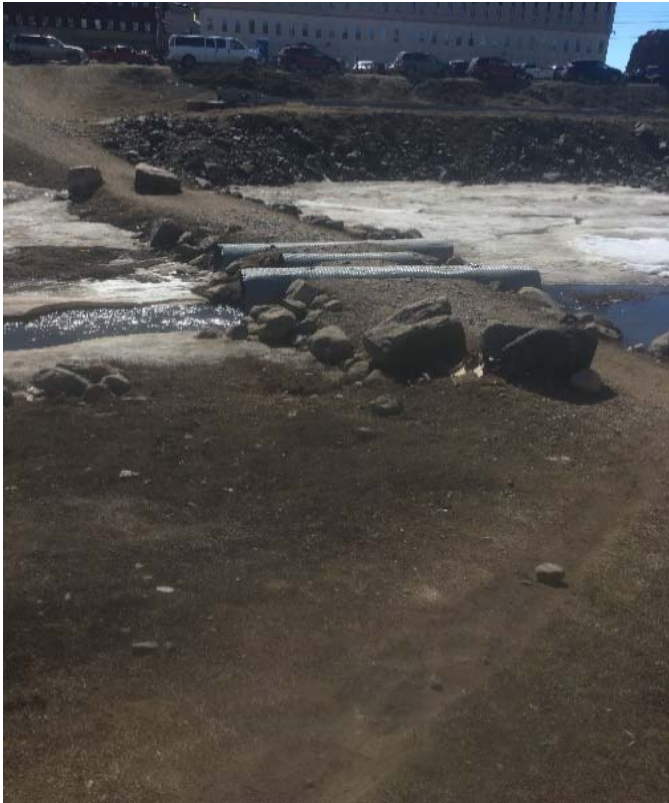
Crossing 6
looking
South West -
2 x 1300 mm
dia., 7 m
long with
one 800 mm
dia. dia
overflow
pipe

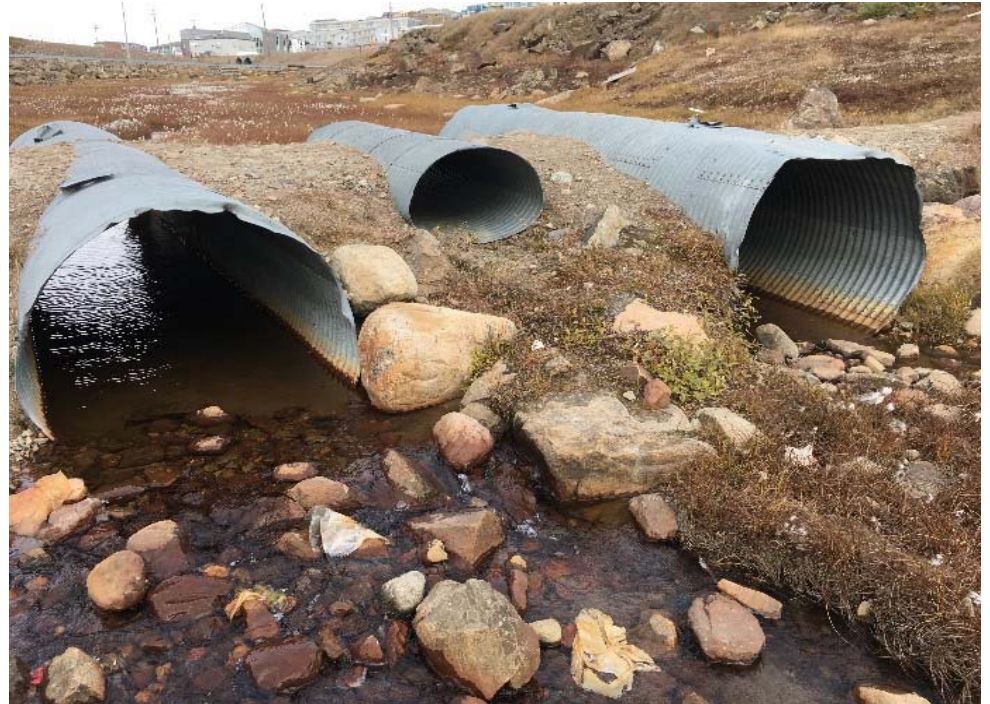
Downstream of Crossing 6 -2 x 1300 mm dia., 7 m
long with one 800 mm dia. dia overflow pipe

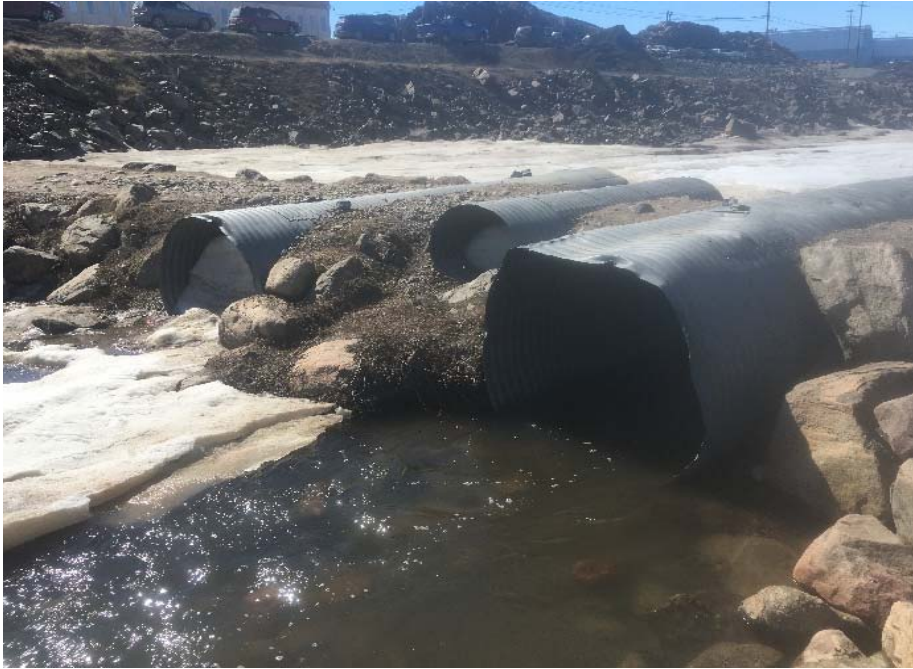
Crossing 6 (2 x 1300 mm dia. and 1 x 800 mm dia. overflow) looking South West -Blocked due to snow

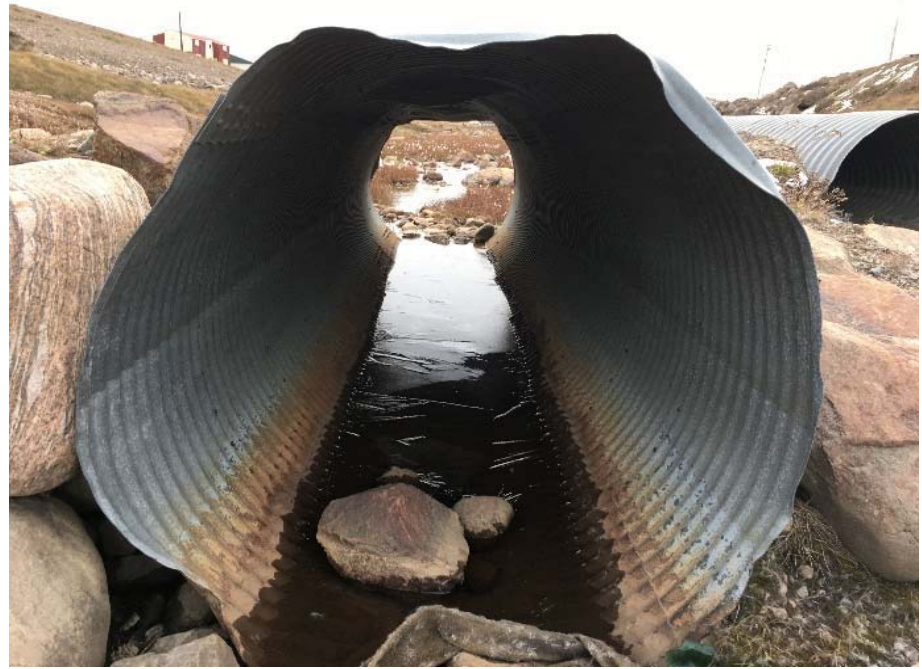
Upstream of Crossing 6 (1300 mm dia.) -Deflected Pipe

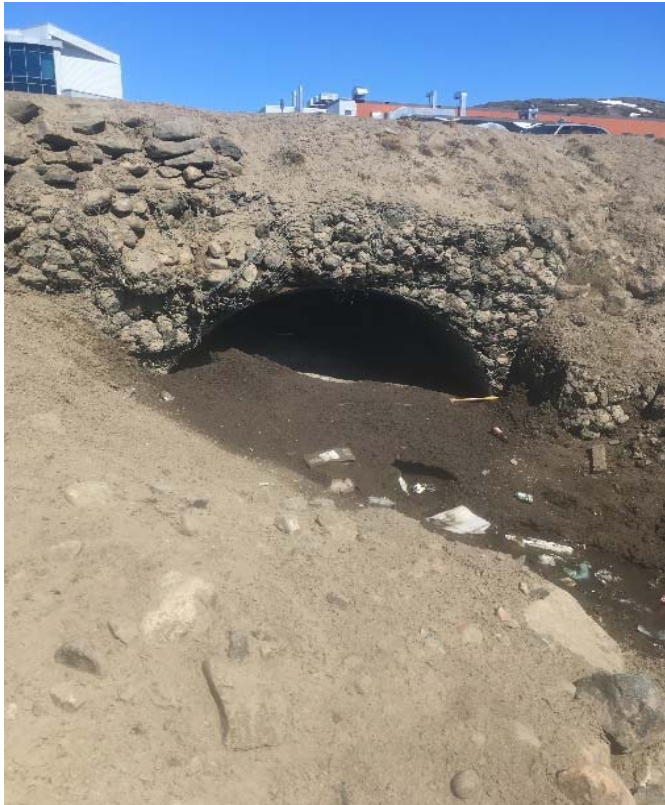
South of
Crossing 7
(3200 mm
dia.) looking
North -Pipe
not
accessible
due to
sediment
buildup

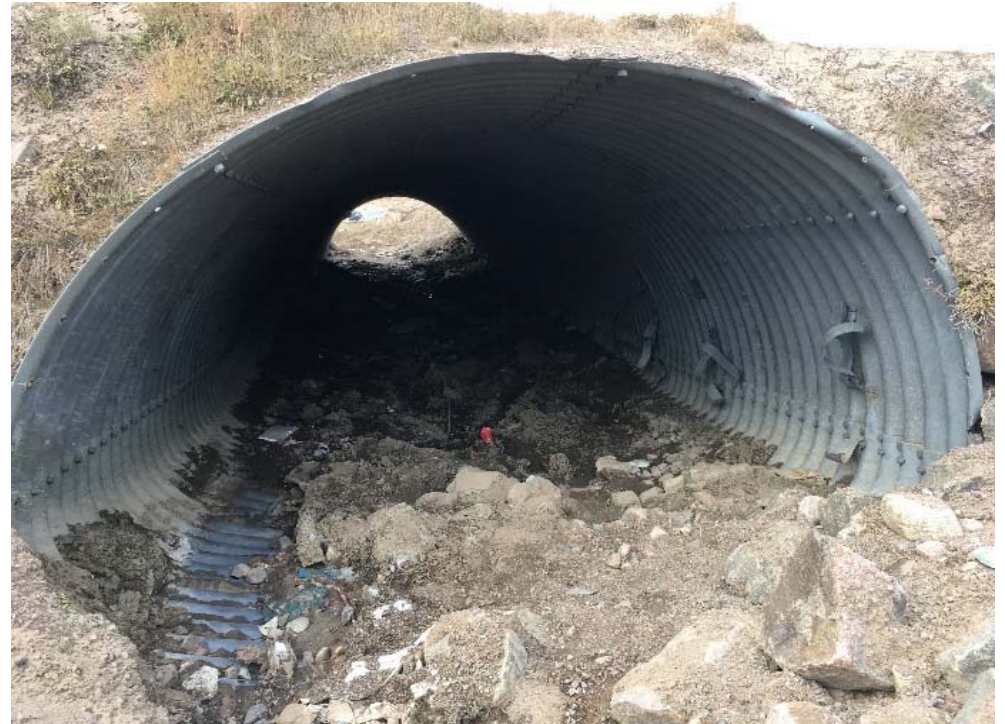
Upstream of Crossing 7 (3200 mm dia.) -Sediment
Buildup inside the pipe

X7	Footings	NW	SE	3200	Wooden Cribs	Arch	Projected	Y	Significant amount of fine and rock deposits in the Culvert. Culvert inoperable.
X8a		N	S	1950	Corrugated Steel	Circular	Projected	N	
X8b		N	S	1950	Corrugated Steel	Circular	Projected	Y	
X9	Dam	N	S						Concrete wingwall is broken ,and not tied in long enough. Undermined structure. Further degradation of dam could result in possible collapse.
X10a		N	S	1350	Corrugated Steel	Arch	Beveled	N	Culvert significantly corroded at the floor, minor gravel deposits observed
X10b		N	S	1350	Corrugated Steel	Arch	Beveled	N	Culvert significantly corroded at the floor, minor gravel deposits observed

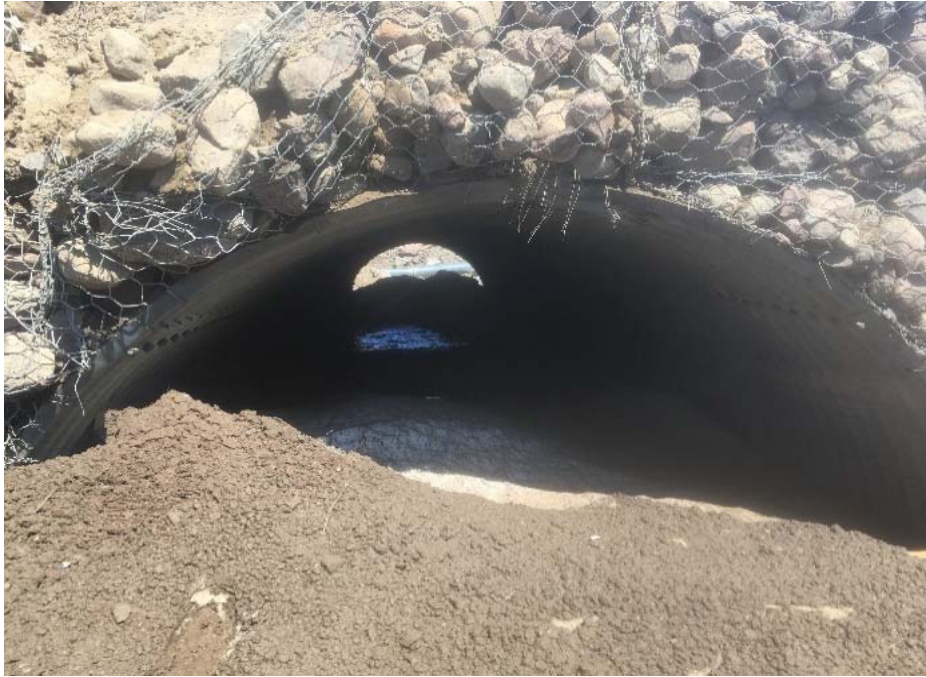
South of Crossing 7 (3200 mm dia.) looking North -
Sediment Buildup

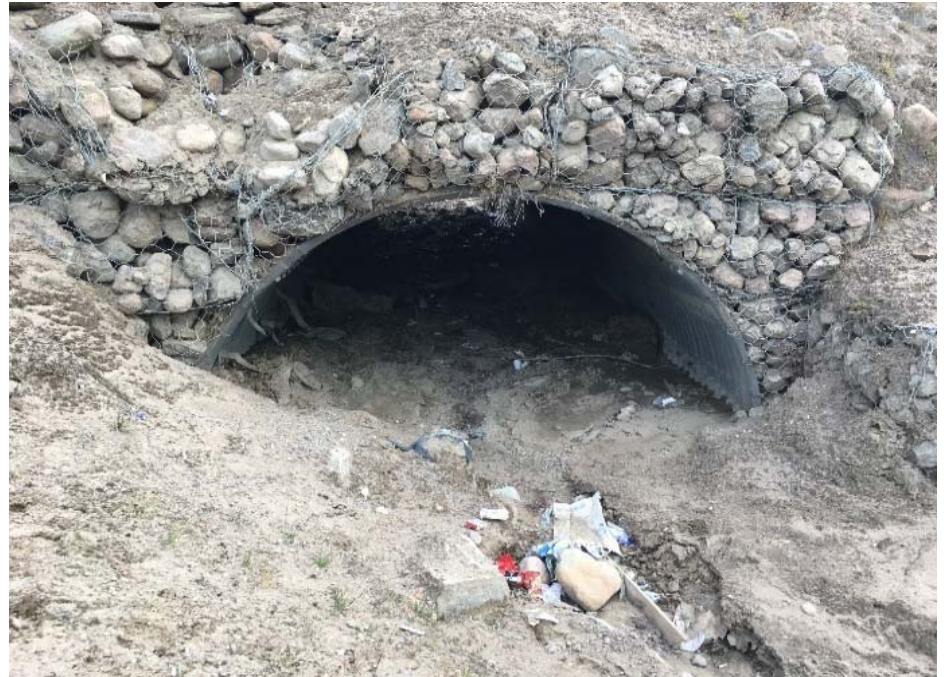
Downstream of Crossing 7 (3200 mm dia.) -Garbage infront of pipe

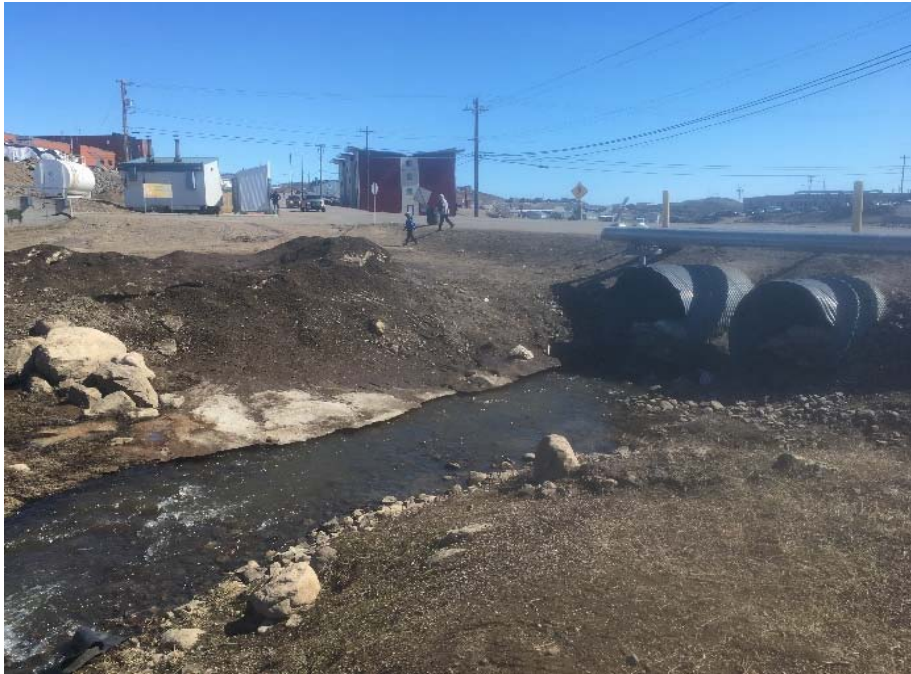
North of Crossing 8 (2 x 1950 mm dia. -22m long) looking Southeast

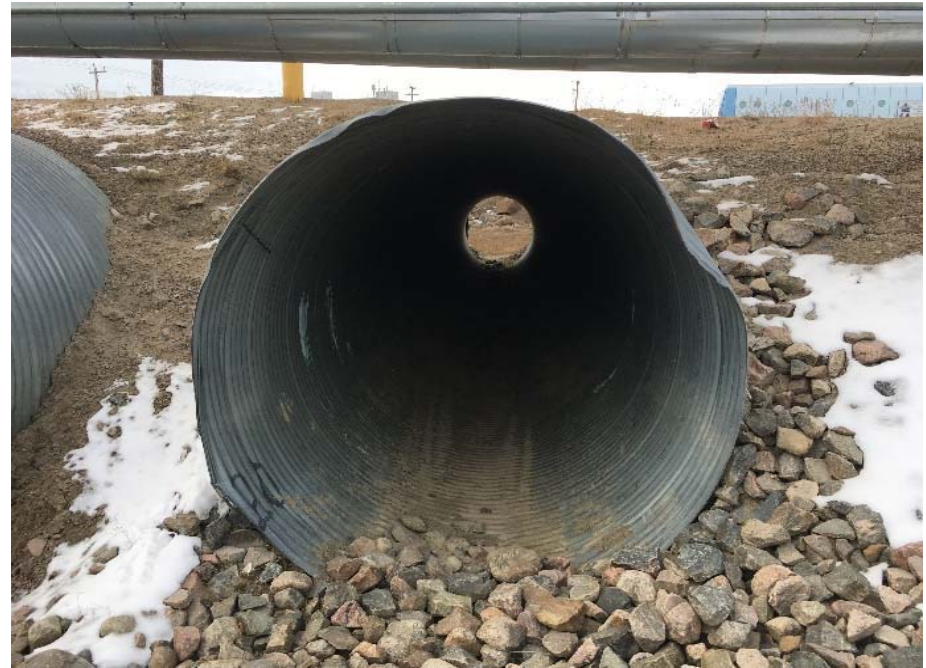
Upstream of Crossing 8 (1950 mm dia.) -Sediment buildup in front of pipe

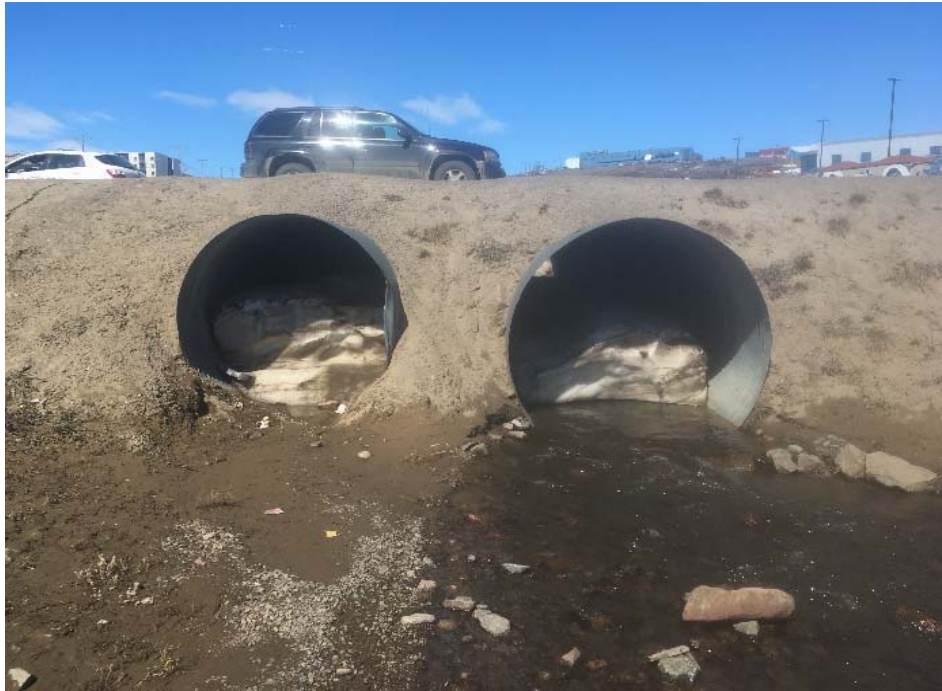
South of Crossing 8 (2 x 1950 mm dia.) looking North
-Blocked due to snow

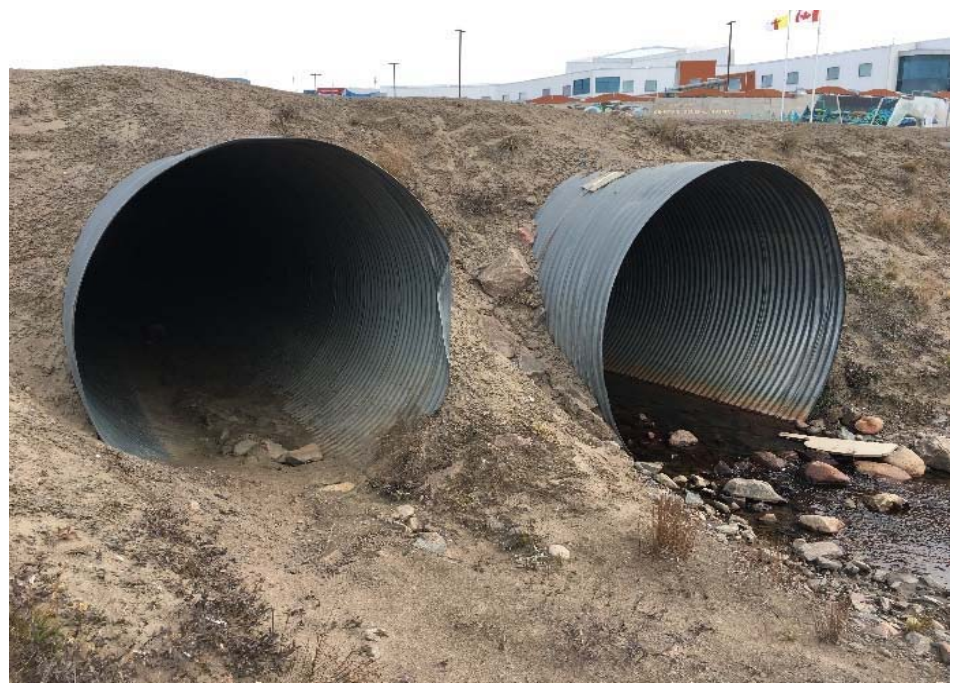
Downstream of Crossing 8 (2 x 1950 mm dia.)

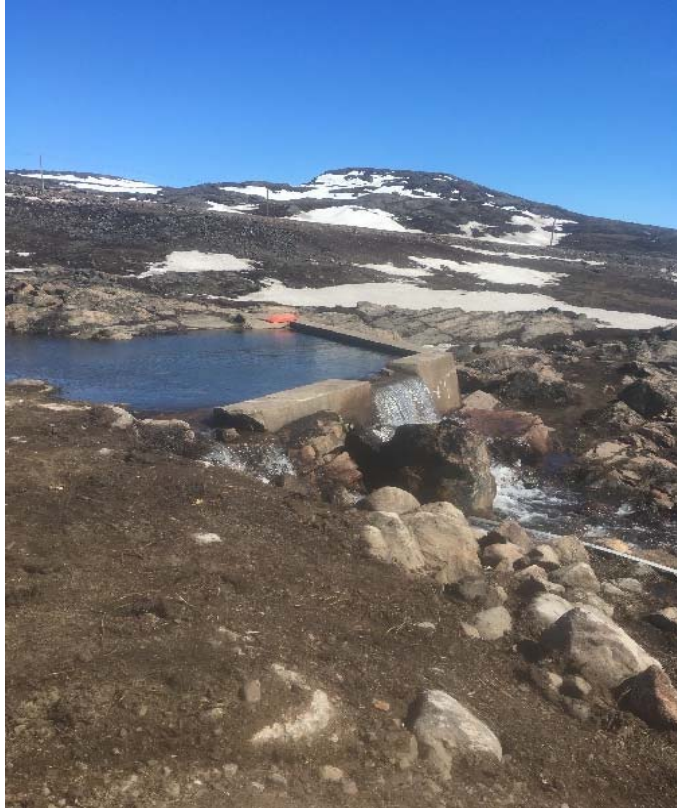
Crossing 9 looking South - Concrete dam, over 1 m drop. Complete barrier, no flow over structure, water flows through rock debris under structure

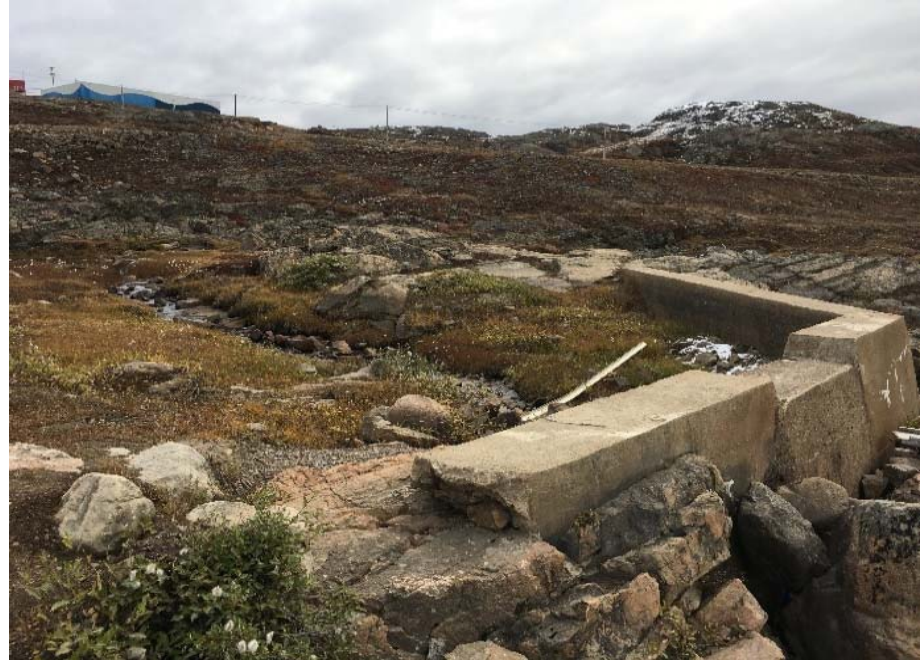
Upstream of Crossing 9 - Concrete dam, over 1 m drop. Complete barrier, no flow over structure, water flows through rock debris under structure

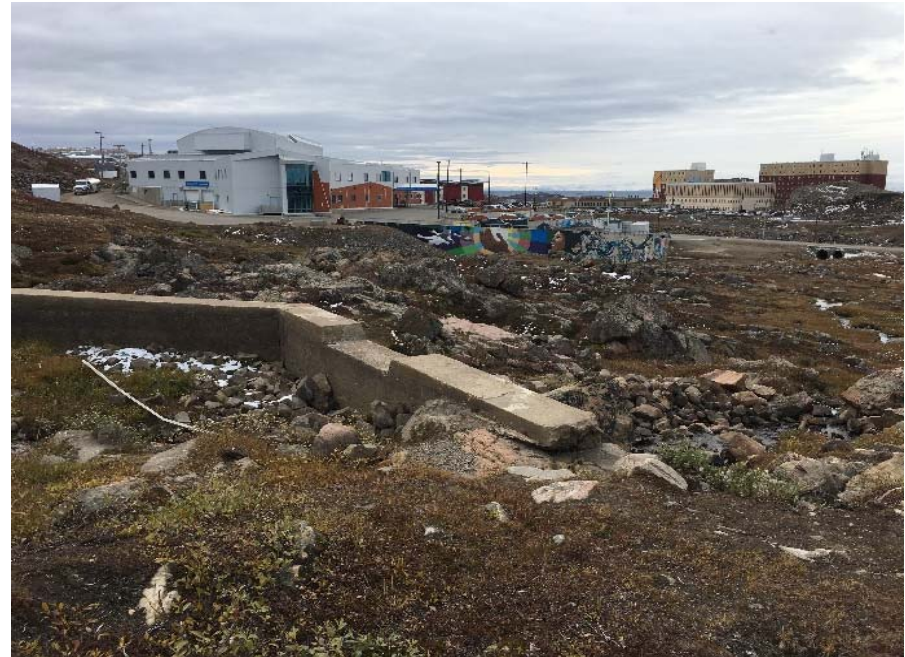
Downstream of Crossing 9 -Concrete dam, over 1 m drop.
Complete barrier, no flow over structure, water flows through rock debris under structure

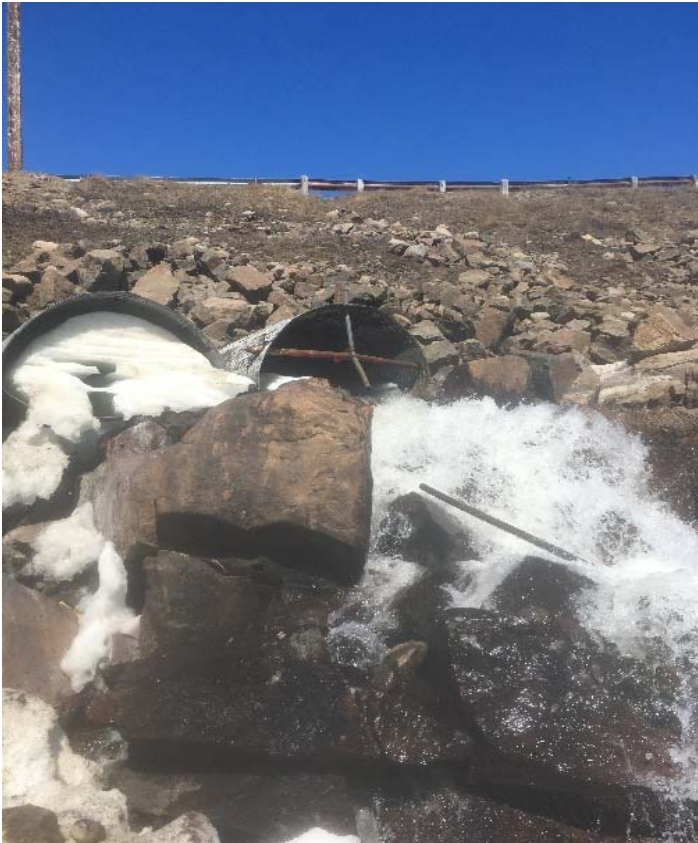
South of
Crossing 10 (2x 1350 mm dia.) looking Downstream -80 m long, steep installation

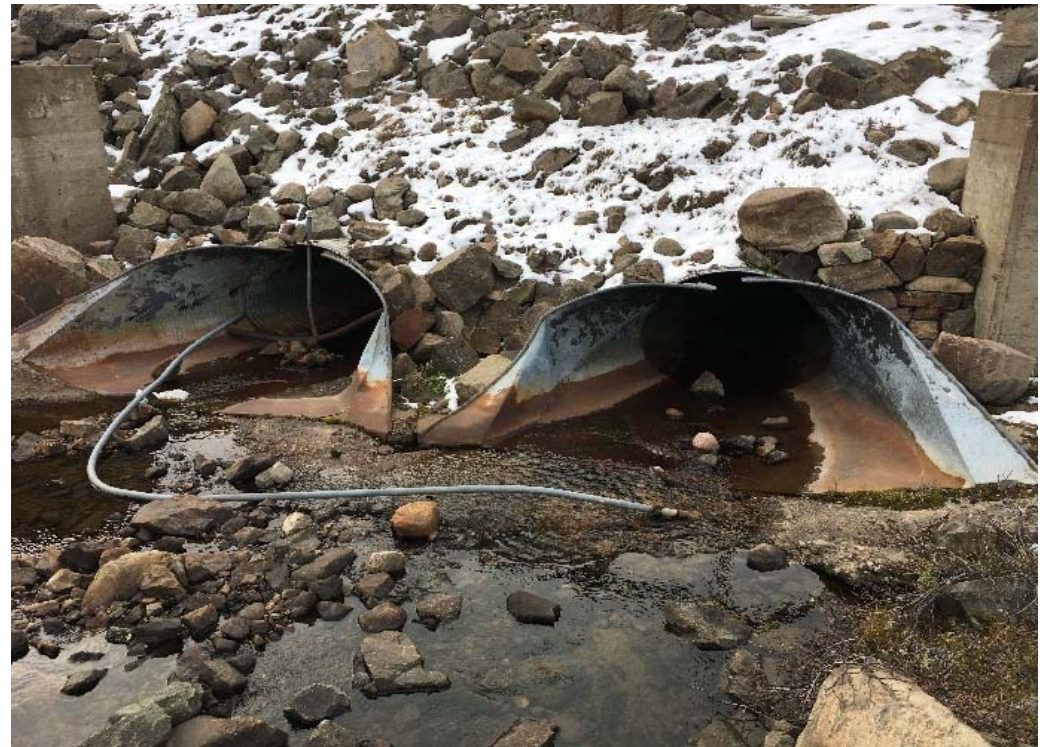
Upstream of Crossing 10 -2 x 1350 mm dia., 80m long, steep installation

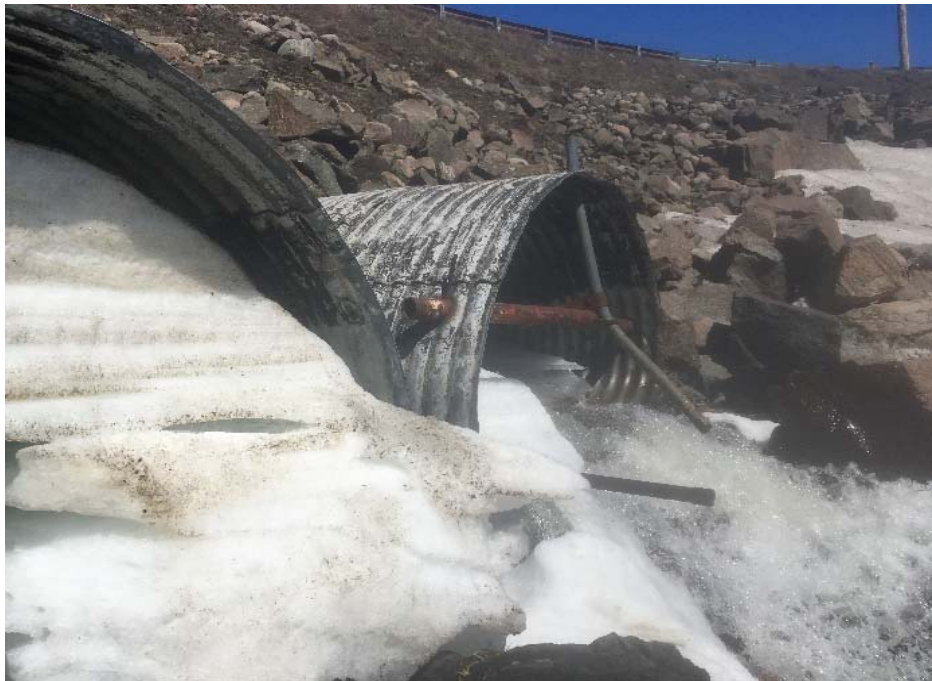
South of Crossing 10 (2 x 1350 mm dia.) looking Downstream -Blocked due to snow

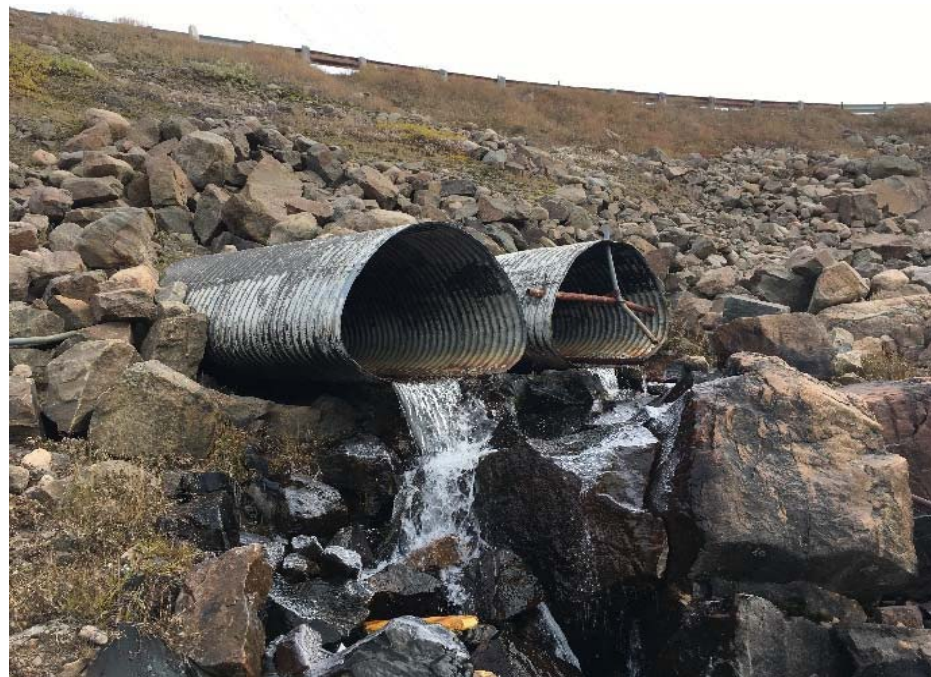
Downstream of Crossing 10 (2 x 1350 mm dia.)
