City of Iqaluit
Master Drainage Plan

Workshop #1

Workshop #2

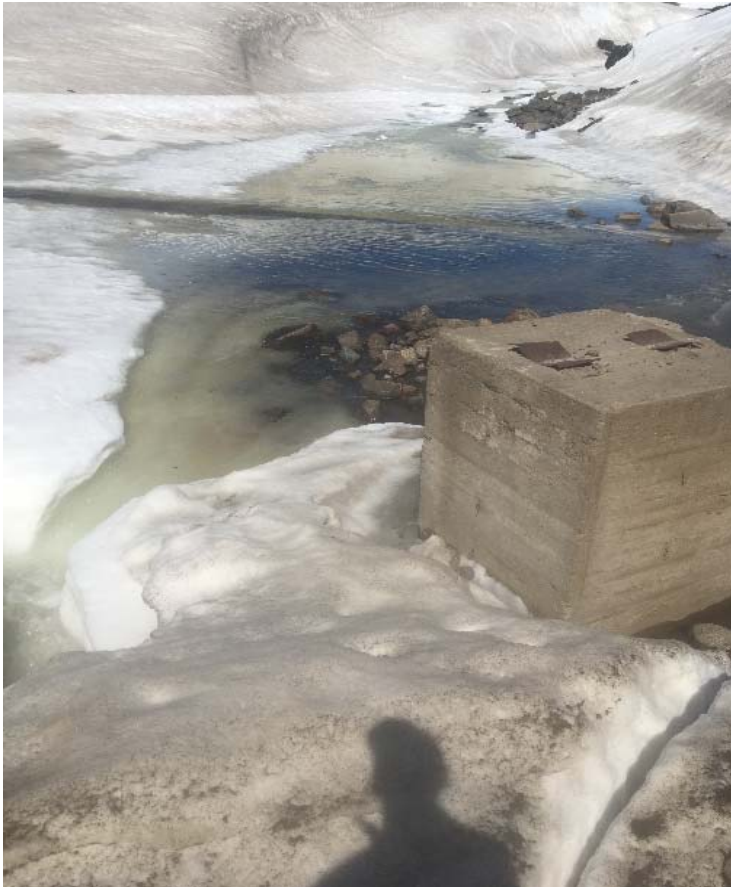
Upstream of
Crossing 10
Looking
North -
Wooden box
identified on
the stream

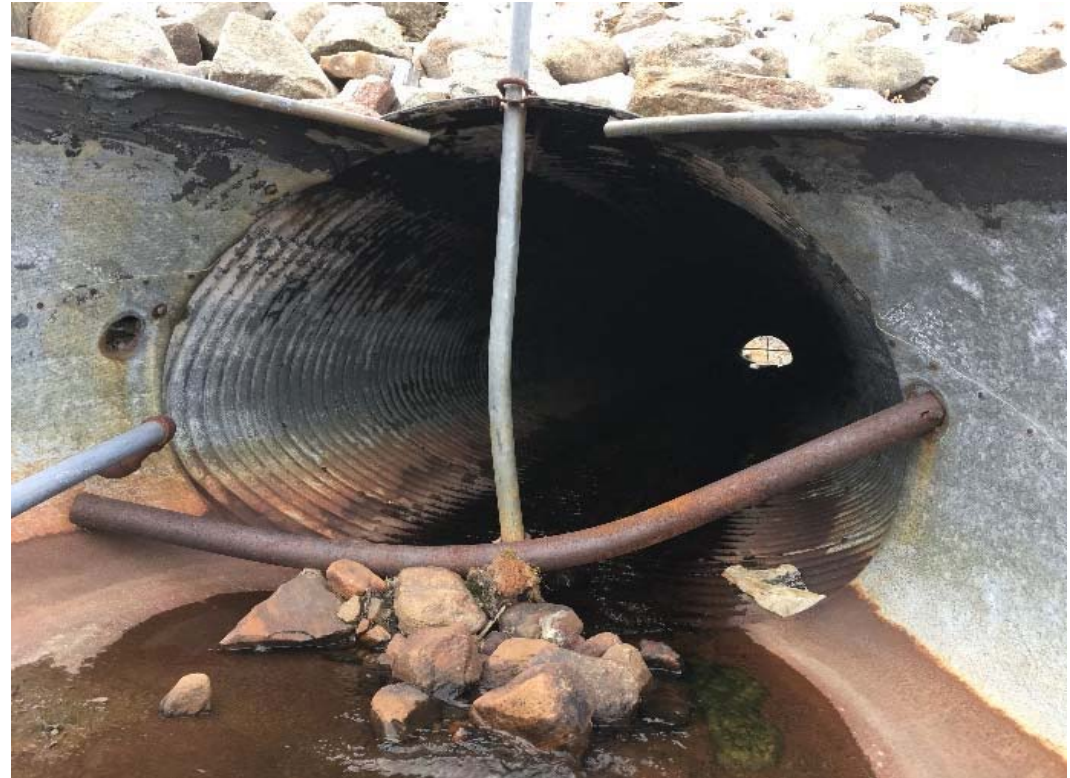
Upstream of Crossing 10 (1350 mm dia.) -Bars in
the pipe

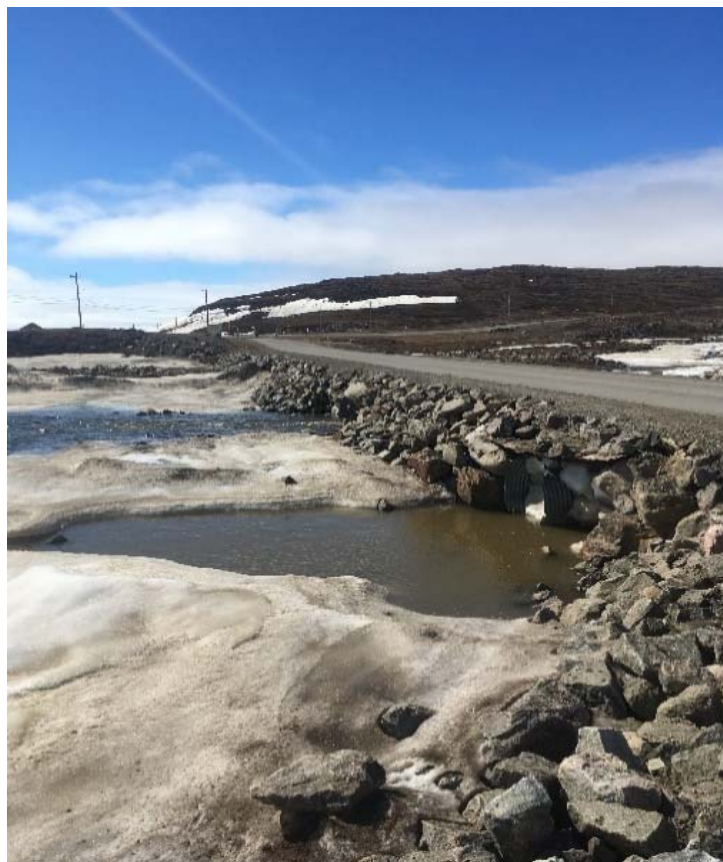
Road of Interest Looking Northwest

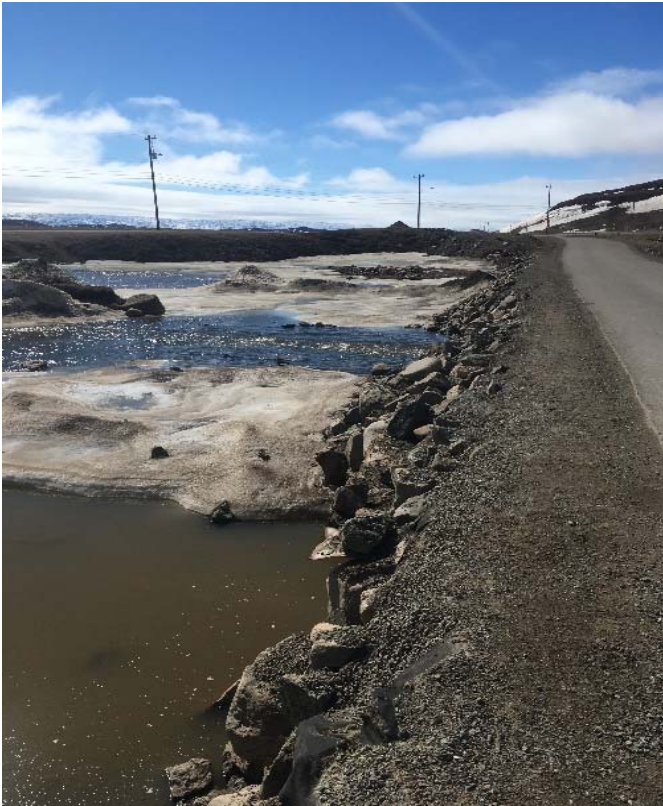
Left Side of Road of Interest - Looking West

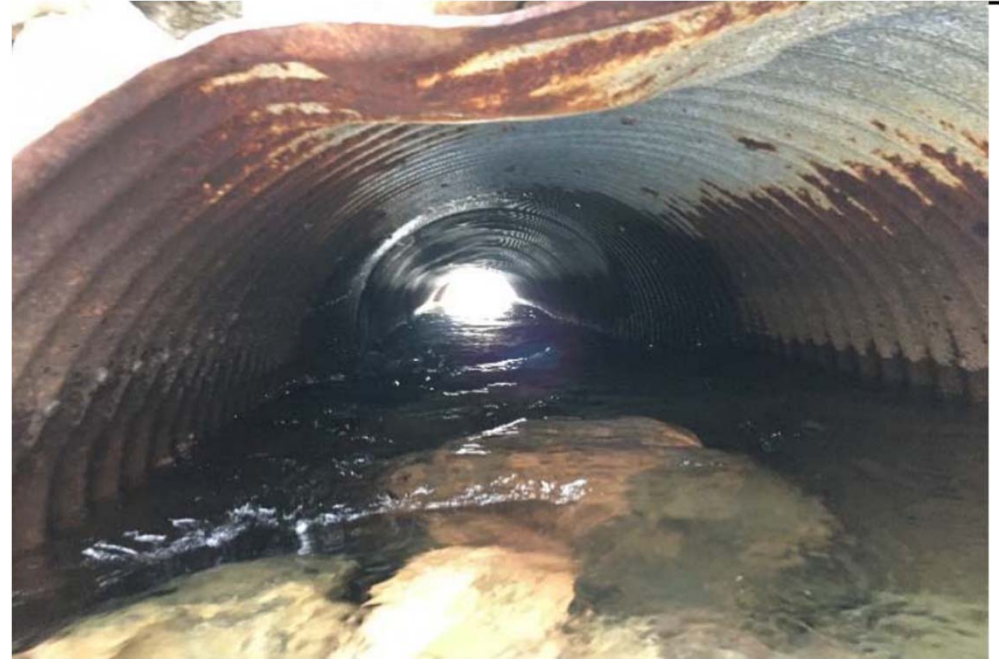
Cluster 2 of 3 Culverts (3 x 1100 mm dia.) on south
side of road - Deflected on the top end

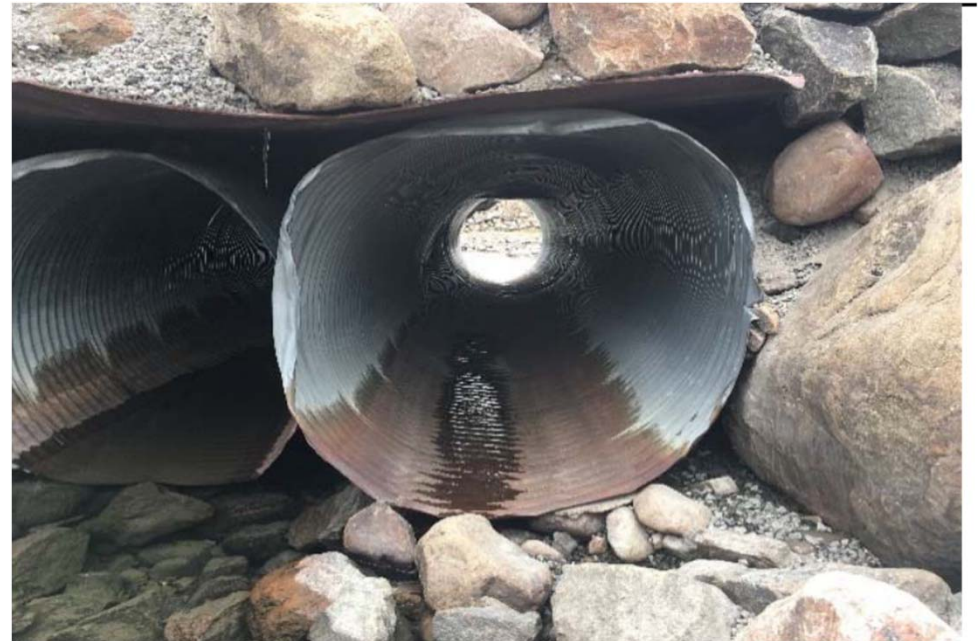
Northside of Cluster 3 - Deflected Pipe due to heavy loads

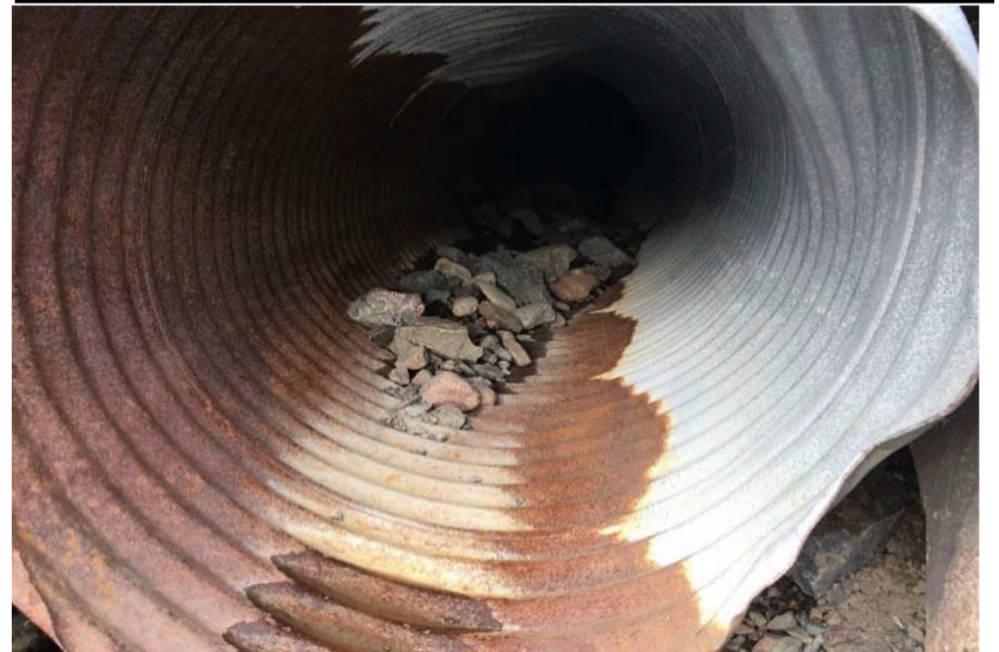
Southside of Cluster 3 - Debris due to sedimentation in the culvert
